ELECTRICALLY INDUCED FUEL GAS FIRES

Mark Goodson, David Sneed and Mike Keller

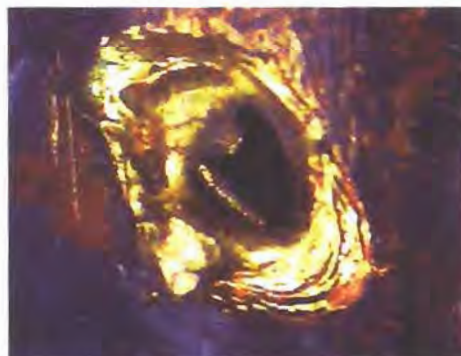
Photo 1. Microscopic view of what was originally believed to be a hacksaw mark.

A photomicrograph of the hacksaw mark is shown in Photo 1, while the flared end of the gas line to the water heater is shown in Photo 2. The hacksaw mark is actually a

notch left in the flex line brought about when the line shorted against the metal case of the furnace. The flare fitting on the gas line has been almost completely disintegrated by electrical activity.

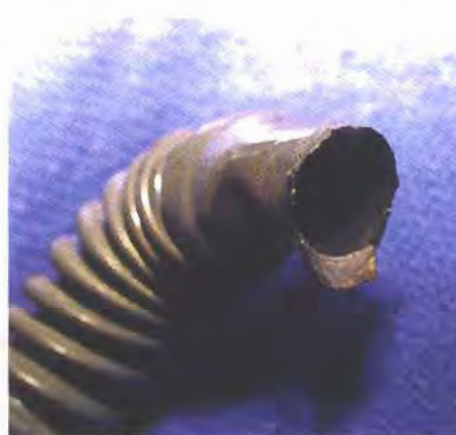
Photo 2. End of flexible gas line with most of the flare having melted due to electrical activity.

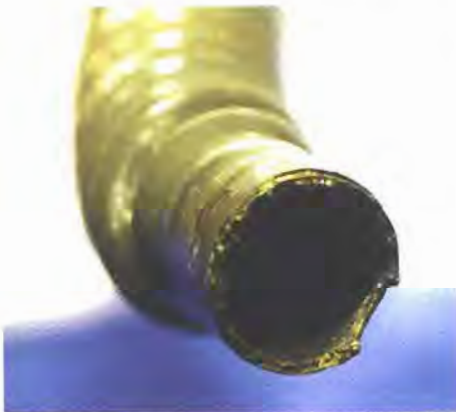
This fire occurred in a heater closet in a residence. The fire was thought to have possible occurred because of some type tampering with the gas lines. The fire originated at a leak in the gas line at the point where the flexible gas line attached to the furnace. Photo 3 shows the end of the flared gas line, it shows almost complete erosion of the flare.

Photo 3. End of gas line with flare being destroyed by electrical activity.

In the enclosed Photo 3, one can see that much of the polymer coating is still present

on the gas line, and yet at the flare the brass has focal melting present. Testing of the polymer coating shows that it decomposes at temperatures of between 400 and 500 degrees F; brass requires temperatures of about 1700 degrees F before it will melt. Clearly, this type of damage cannot be from flame impingement. It is also noted that the brass flare is well protected from flame by the brass nut that definite lines of demarcation. In a distance of about 1/8", the heating of the arc will cause a transition to be made from melted brass to non-melted brass, and from no polymer coating (completely pyrolyzed) to an intact polymer coating. This rapid transition from extremely damaged (melted) brass to undamaged polymer is a very typical of an electric arc. Were the thermal damage caused by a flame, there would have been greater areas of heat stressing of the polymer coating.

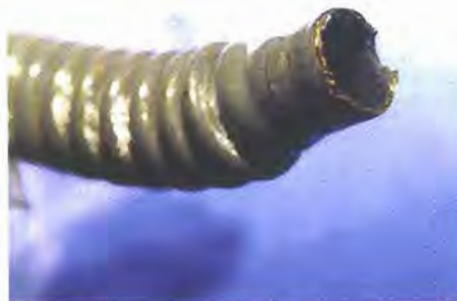
Photo 4. Side view of gal line in Photo 3, with the polymer coating still relatively intact because of protection provided by the brass nut.
