EXAMINATION OF FIRE DAMAGED  
METAL OXIDE VARISTORS  
Mark Goodson, PE Lee Green, PE

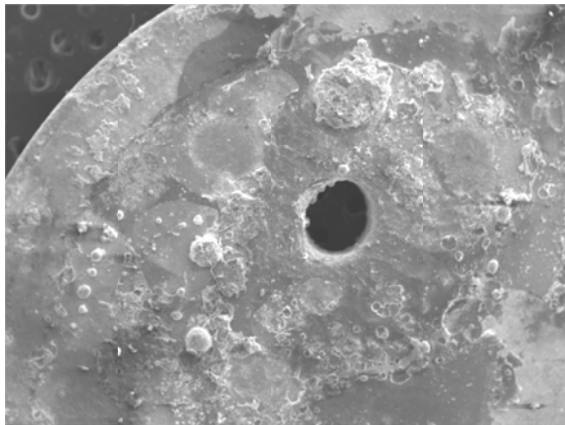
**Picture 1 – hole through MOV**

The investigation of a fire brought on by a failed MOV can be a straight forward task, or one filled with perils. The ZnO has a high Melting Point (MP) of 1975 deg C. As such, MOVs survive almost every fire. The leads will be detached, and the epoxy will be consumed, but the MOV body will be intact. Testing of several thousand MOVs in TOV situations has shown that the predominant failure of MOVs manifests itself by a 'hole' being found in the MOV. Picture 1 shows such the SEM image of such a hole.

It is our opinion that post fire MOV evaluation has some use utility in a fire investigation, but that the utility is limited. If the MOV has a hole present, one needs to look for the cause (floating neutral, energized ground), as well as determine what types of fusing or other protection were present. If an arced lead for an MOV is found, this is an indicator of an MOV that is in runaway.

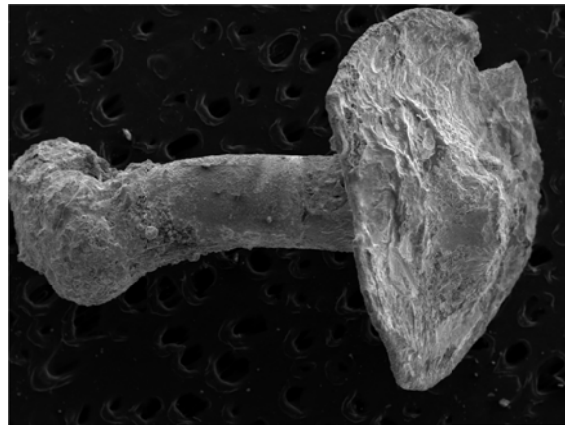
**Picture 2 – Arced Lead of MOV attached to PCB**

There is a second mode of failure that can occur, and that is when the lead arcs off the MOV body. Our testing showed about 7 % of MOVs that catastrophically failed after a TOV condition had no visible damage to the MOV, but instead had arced leads. A fire can still occur, but

investigation of the fire becomes very difficult. The leads may or may not be found; if the MOV is found, it will be intact in appearance. But without the leads, one cannot state that an MOV failed and caused an overcurrent situation with a resultant fire. Picture 2 shows a lead that failed on an MOV that was soldered to a PCB. The right side of the photo depicts the circuit board pad, while the left side of the lead depicts 'clubbing' associated with arcing.

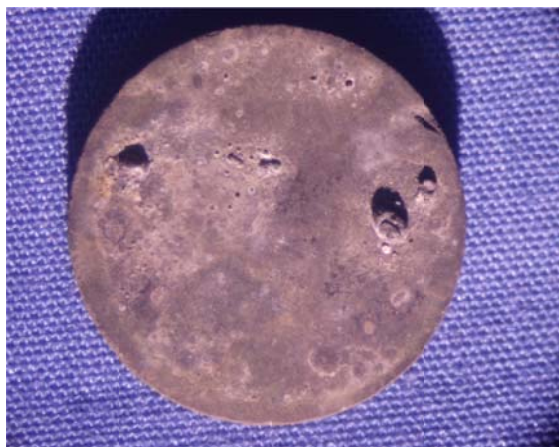
**Picture 3 – MOV from GFI**

Picture 3 is typical of an MOV that started a fire, but which has no holes in its body. Without the leads being available for examination, is there sufficient data to state that the MOV was or was not in runaway mode? In fact, the only data available is that of breakdown / knee voltage at the usual 1 mA AC level, 60 hertz. To get right to the point, the real issue is the fire – given the high MP of the ZnO, will the fire change the MOV in such fashion that its condition *a priori* can be determined?

When the MOV body is intact, and the leads are not recovered, breakdown voltages both pre and post clean should be obtained. Thereafter, one can conclude that the MOV was not causative (the breakdown voltage exceeds available line voltage) or the role is indeterminate – the MOV may or may not have gone into runaway and caused overcurrent on the leads.

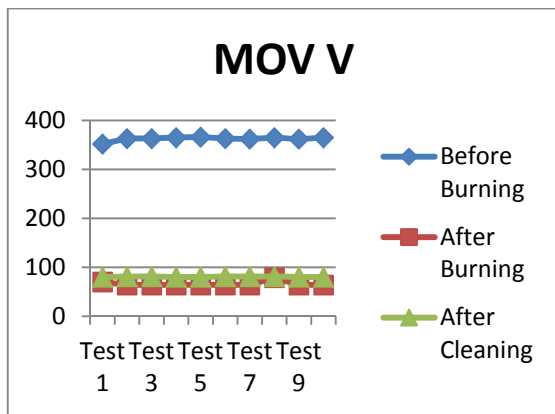
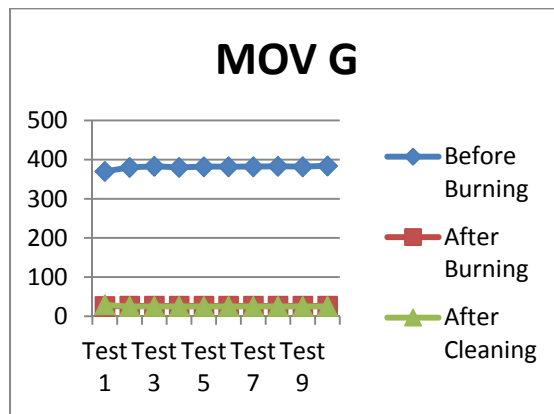
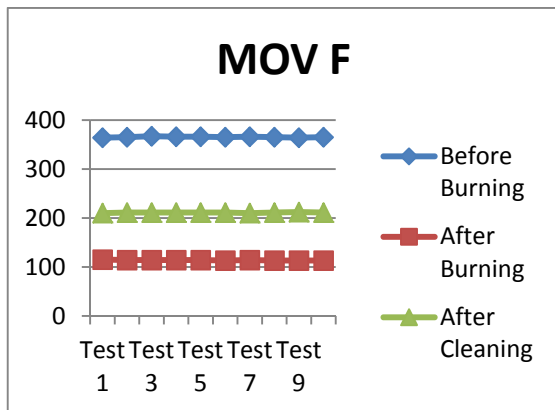
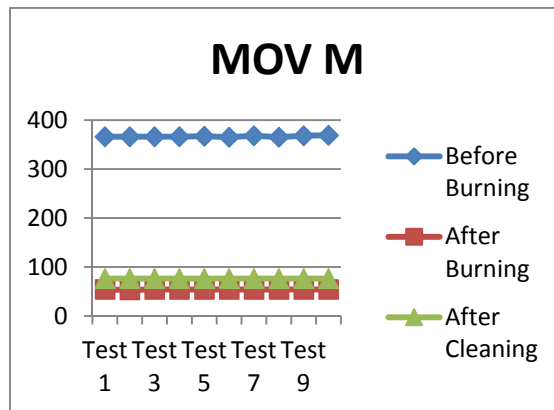
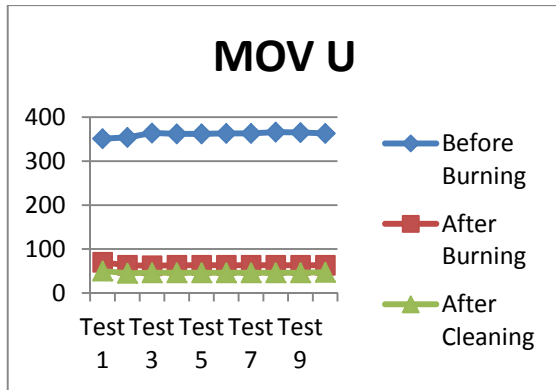
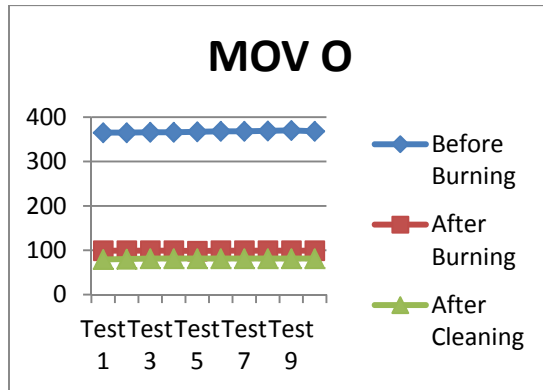
What can be stated is that for all 48 MOVs, there was a downward shift in the breakdown voltage. In no case did the voltage rise. This data alone is helpful, in that a post fire breakdown voltage on an MOV that is above the line voltage can immediately be dismissed in terms of having the MOV causing the fire.

The finding that was the most puzzling was the change in breakdown voltage between *pre* and *post* clean states. There was not a monotonic change. For some MOVs, cleaning caused the breakdown voltage to increase (as would be expected), and at times the breakdown voltage dropped after cleaning. The enclosed graphs show that MOVs V, F and M all had rises in breakdown voltages after cleaning, while MOVs U and O saw voltages drop after cleaning. The MOV G functioned almost the same before and after cleaning.

We did note that several of the MOVs varied in their breakdown voltage post fire, but before cleaning. The MOVs I and B demonstrate the value in the taking of multiple readings. Both MOVs demonstrate that cleaning is effective in at least taking the MOV to a point where it can be tested in a repeatable fashion. The MOVs also demonstrate that contamination post fire will prevent obtaining reliable readings.
