FIRES CAUSED BY FRACTURED RESISTANCE HEATING ELEMENTS

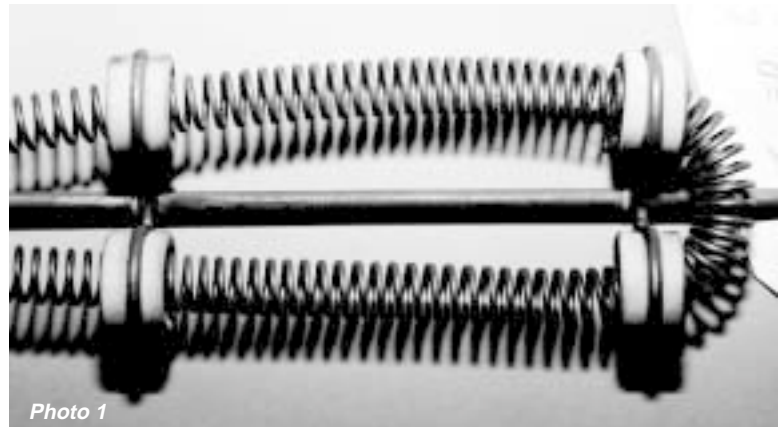
Photo 1

In Photo 1, we note that the coils (loops) of this element are relatively uniformly spaced. Such uniform spacing creates a relatively constant surface temperature for the element. At 240 VAC, with a fan blowing (as in actual use), surface temperatures were approximately 470 deg F when measured with a thermocouple. This temperature, however, will lessen as the heater element is used. A nominal 5000 watt heater will drop in wattage (and thus heat output) as a function of time. As with the lightbulb filament, the heater element becomes smaller in diameter over time. On the heater element, this reduction in cross sectional area is due to oxidation. The smaller cross sectional area increases resistance, which thus decreases wattage.

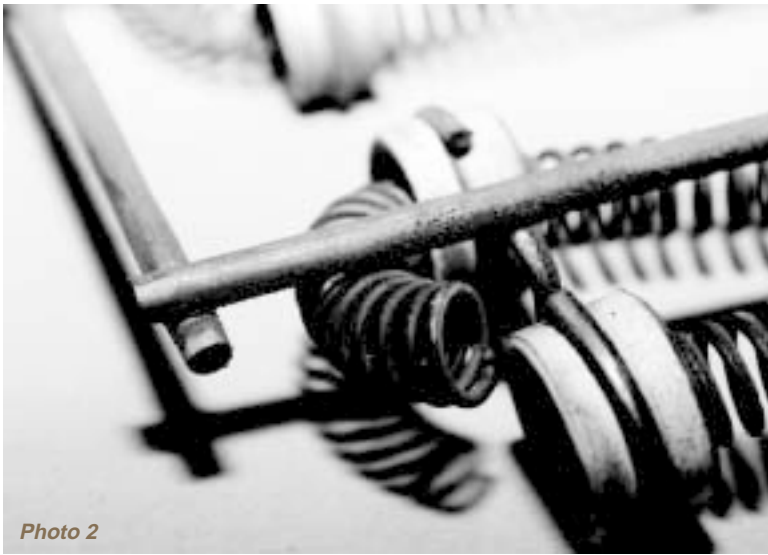
A second manner of fire causation occurs when the failing element welds itself onto the grounded metal frame. Photo 2 shows a furnace heating element where this has occurred. Diagram 1 shows the

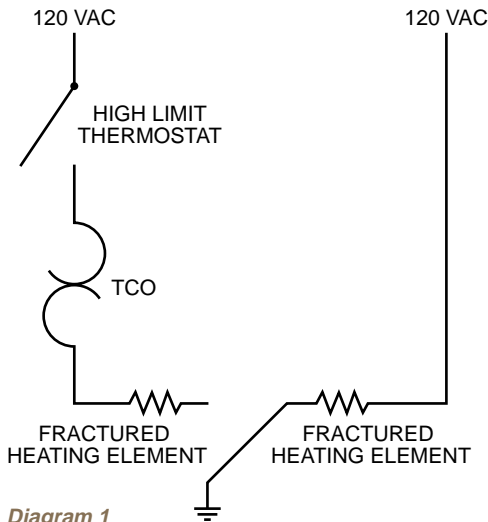
Diagram 1

schematic of this element, before and after failure. On a 240 VAC appliance, because often only one leg is switched, the other leg is continually powered. The now shorted element will continue to heat, without benefit of a high-limit thermostat or Thermal Cut Off (TCO). The

heating can go on for hours or days until a fire is created; once again, we do need combustibles for ignition to occur. The heat that is generated from a normally operating heating element will be dispersed by the air from the blower; when the heater has welded and is on continually, the heat flux will accumulate because there are no air currents to remove the flux.

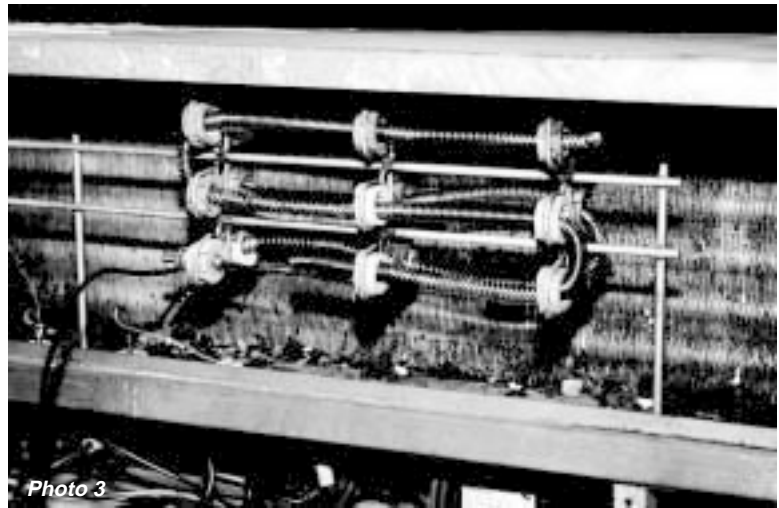
Photo 3 shows a resistance heating element that came from a failed furnace; the furnace had two elements, and this is the one that did not fail. Surface temperatures varied from 460 to 790 degrees F, depending on turns density. This increased temperature results in a severe increase of oxidation rate where the turns are dense, and a corresponding decrease in element life. Photo 4 shows the infrared thermogram of this same heating element when powered.

The element depicted in photos 3-4 came from a furnace that had a second element, with the second element being the one that caused the fire. The failed element is depicted in photos 5 and 6. Photo 5 is a photomicrograph of the element in portions that are appropriately spaced. Photo 6, shows the increased turn density that was responsible for the failure. Also note that there are 'balls' of splattered metal from the heating element's base material, these having been generated in the arcing process. It is these balls that caused ignition of nearby combustibles.
