# Transformer and Cable Sectioning

Mark Goodson, PE  
Michael Shuttlesworth, EIT  
Goodson Engineering  
Denton, Texas

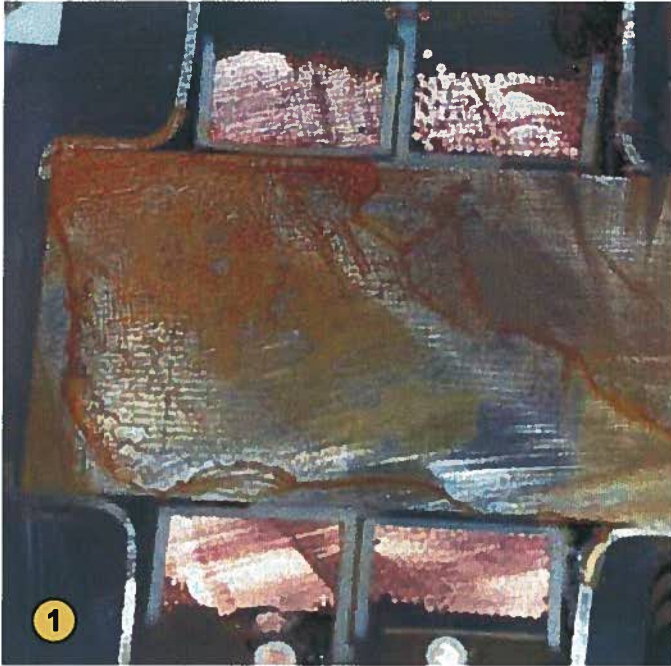
Photo 1 shows a cross section of a transformer after it has been potted and sectioned in half. The primary windings are on the left and the secondary are on the right.

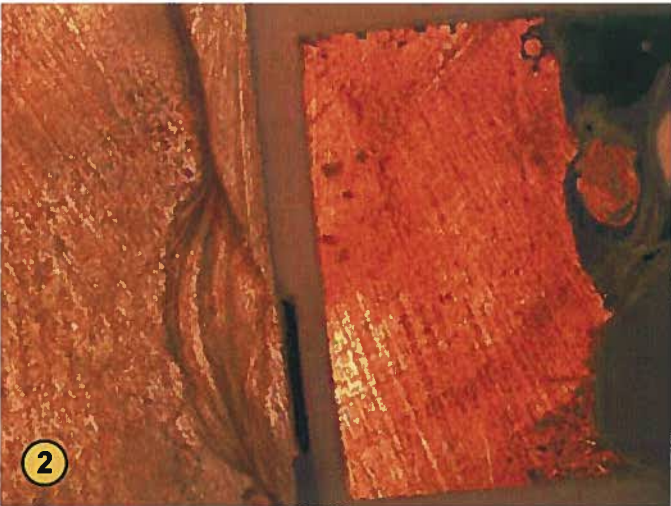
Photo 2 is a microscopic view of the primary windings (the right side of the picture) after sectioning (sawing) but prior to polishing. Notice how the fine conductors are somewhat smeared together by the action of the cutting wheel. The material to the left of the picture is a part of the iron core / laminate stack.

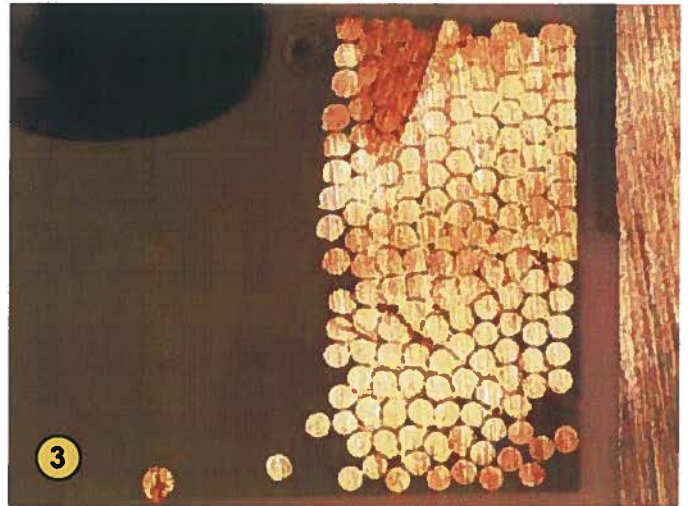
Photo 3 depicts the secondary windings after polishing with 180 size grit. The majority of the conductors are easily counted on the secondary at this point.

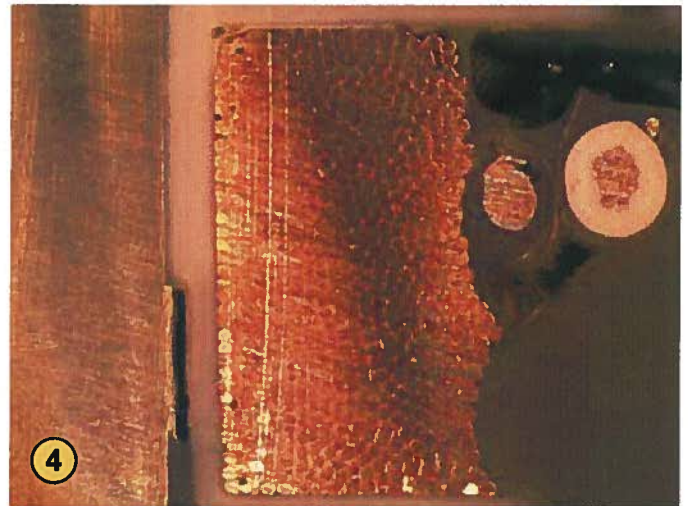
Photo 4 depicts the primary windings after polishing with 320 size grit.

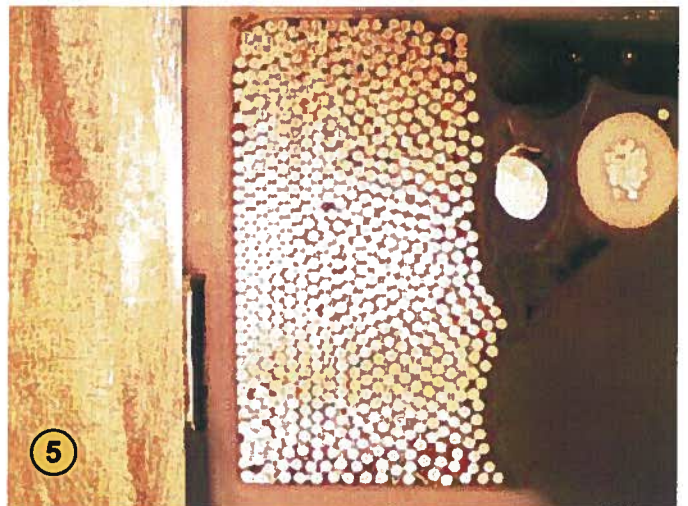
Photo 5 depicts the primary windings after polishing with 600 size grit.

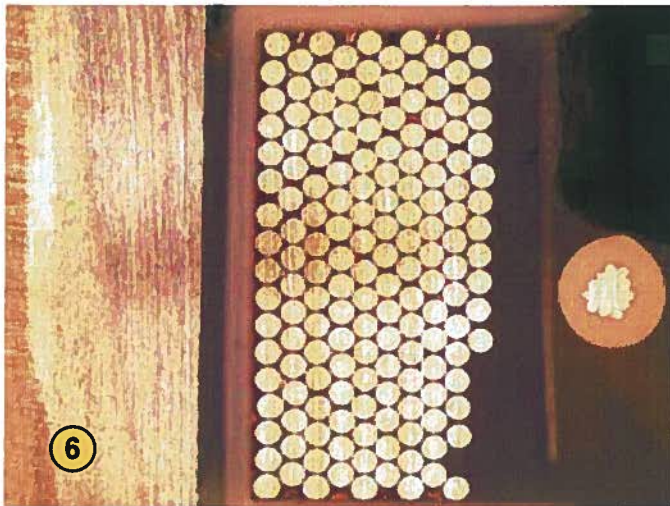
Photo 6 depicts polishing of the secondary with 600 size grit. (Note: this is a different side of the secondary than is shown in Photo 3).

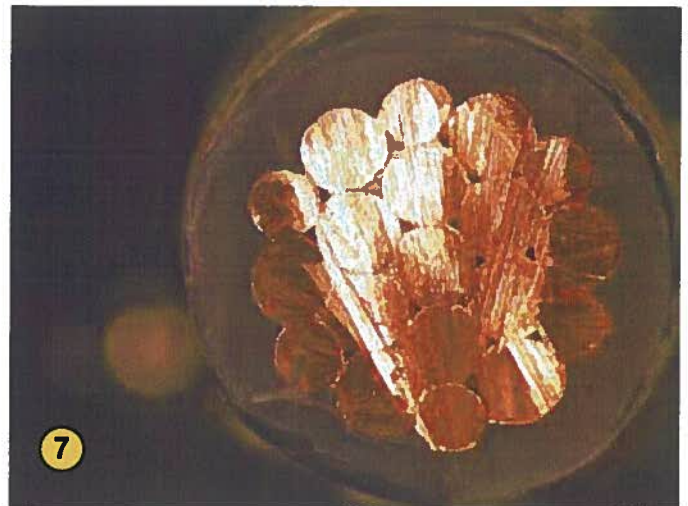
Photo 7 shows the cross section of a conductor that has been sectioned, but not polished.

In one examination the authors were involved with, a claim was made that the cabling used was undersized. The engineer making this claim had measured one of the 19 strands, determined its cross sectional area, and multiplied by 19 to obtain the effective wire gauge. A section of the cable was potted and cross sectioned, and the error of that engineer's assumptions was shown. There ARE 19 strands, but the strands are not all the same size, as shown by photos 7 and 8.

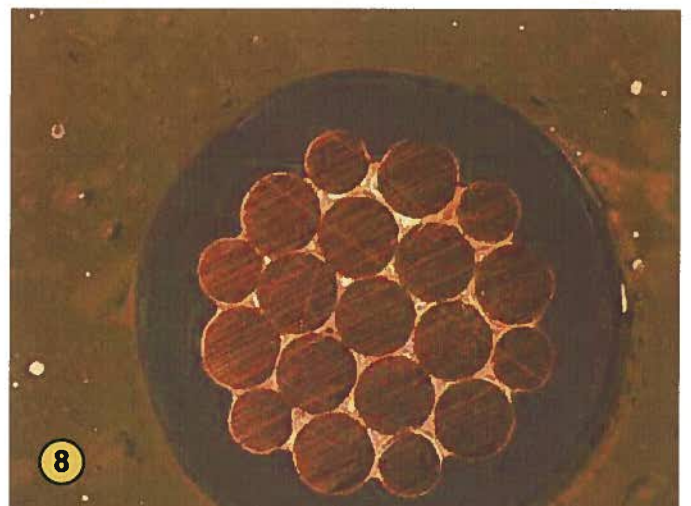
Photo 8 shows the same cable as in photo 7, but with polishing at the ~ 2000 grit level, using a polishing cloth. Note that the outer 'ring' of conductors has 6 larger conductors alternated with 6 smaller conductors.
