USE OF BOND WIRES IN ICS IN FIRE INVESTIGATION

Mark Goodson PE
Lee Green PE
Michael Shuttlesworth PE
Goodson Engineering
Denton, Texas USA

ABSTRACT

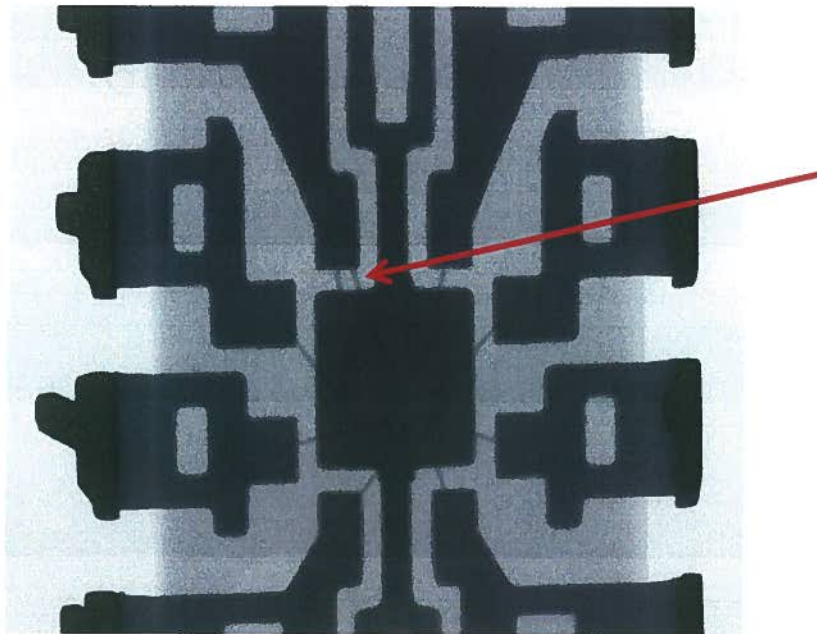
Photo 6 – X-Ray View Showing Bond Wires On The LM 386. Note The Double Bond Wire On The Ground Lead, Indicated By Arrow.

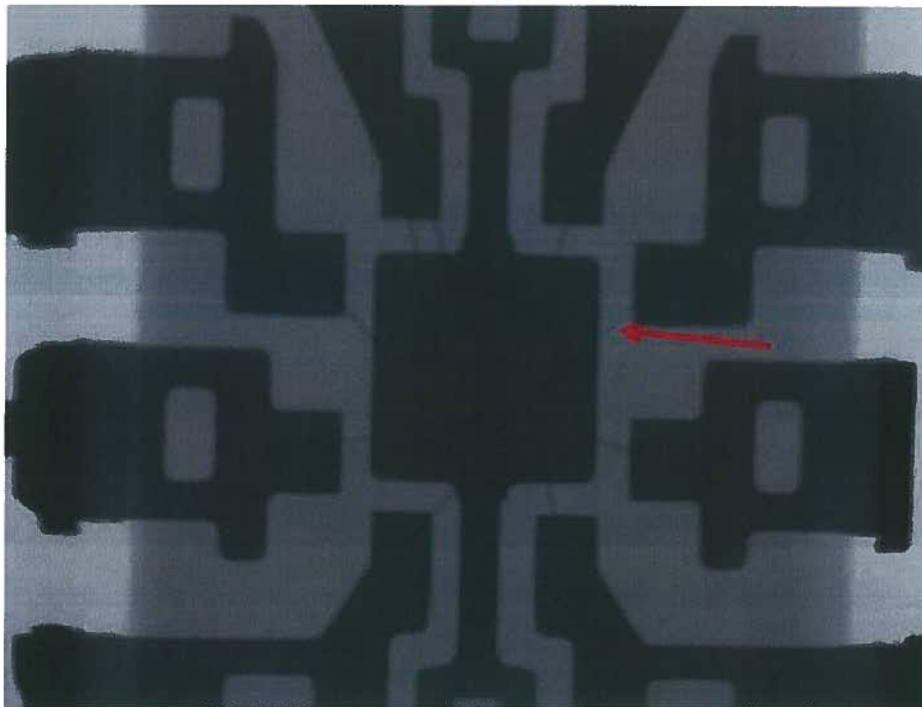
We took an LM 386 amplifier, and applied 36 volts to it, across the Vcc and ground terminals. Testing of the IC thereafter showed that it had failed. MF RT x-ray showed that a wire was missing, corresponding to pin 4. Photo 8 shows the location of the missing wire. After noting the missing wire, the IC was subjected to CT (Computed Tomography) and then reconstruction. For software, we used a program called *Volume Graphics (VG)*, published in Germany. Using VG, the reconstructed image was analyzed, and is shown in Photo 9. The VG reconstruction shows that the bond wire serving pin 6 has evaporated. A review of the schematic shown in Photo 7 indicates that pin 7 is Vcc, the supply pin.

Photo 8 – Note The Lack Of A Bond Wire On Pin 6.

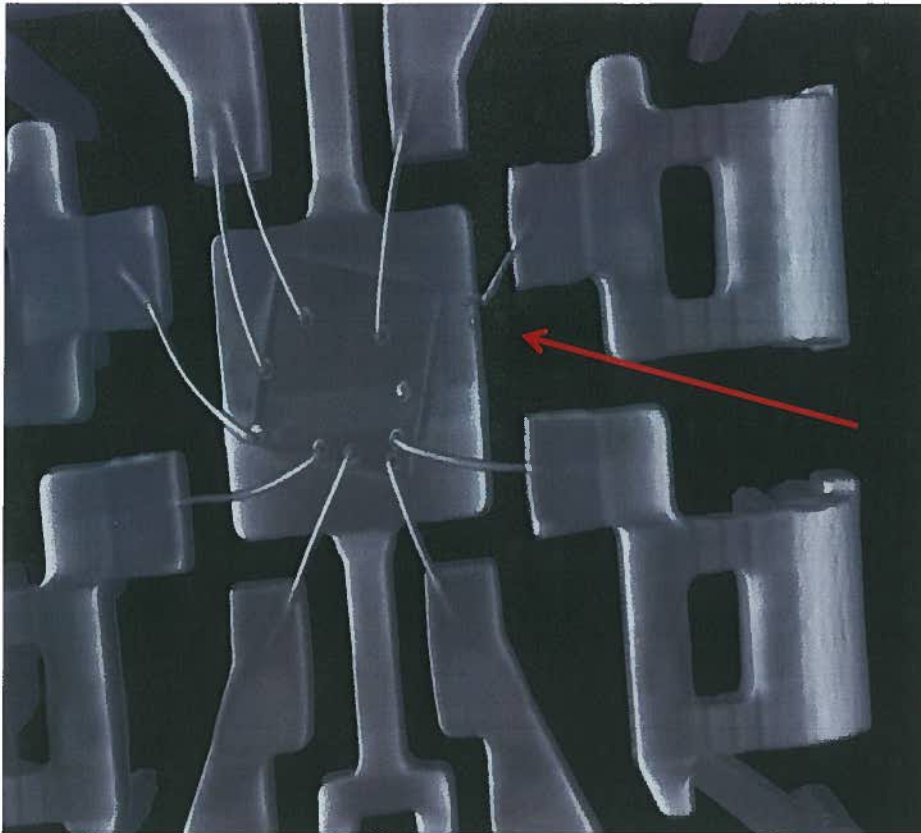
Photo 9 – VG Reconstruction After CT, Shows Remnants Of Evaporated Wire On Pin 6

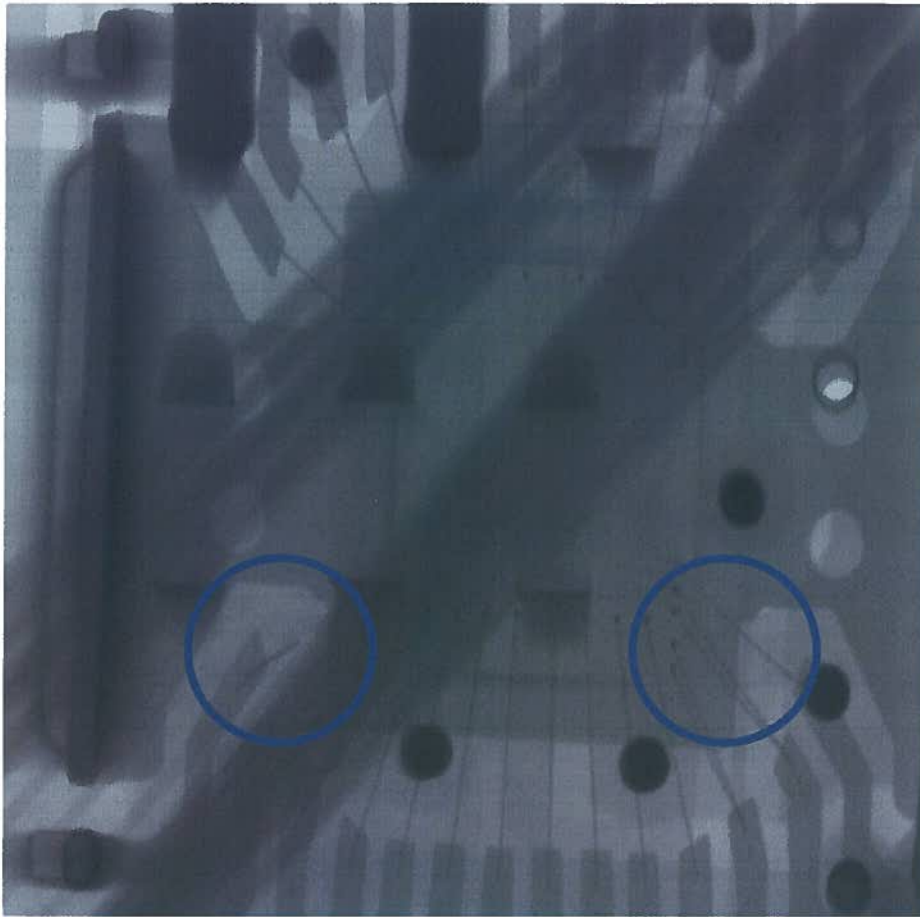
Photo 10 - Possibly Damaged IC From DVD Player – Circles Indicate Areas Of Interest

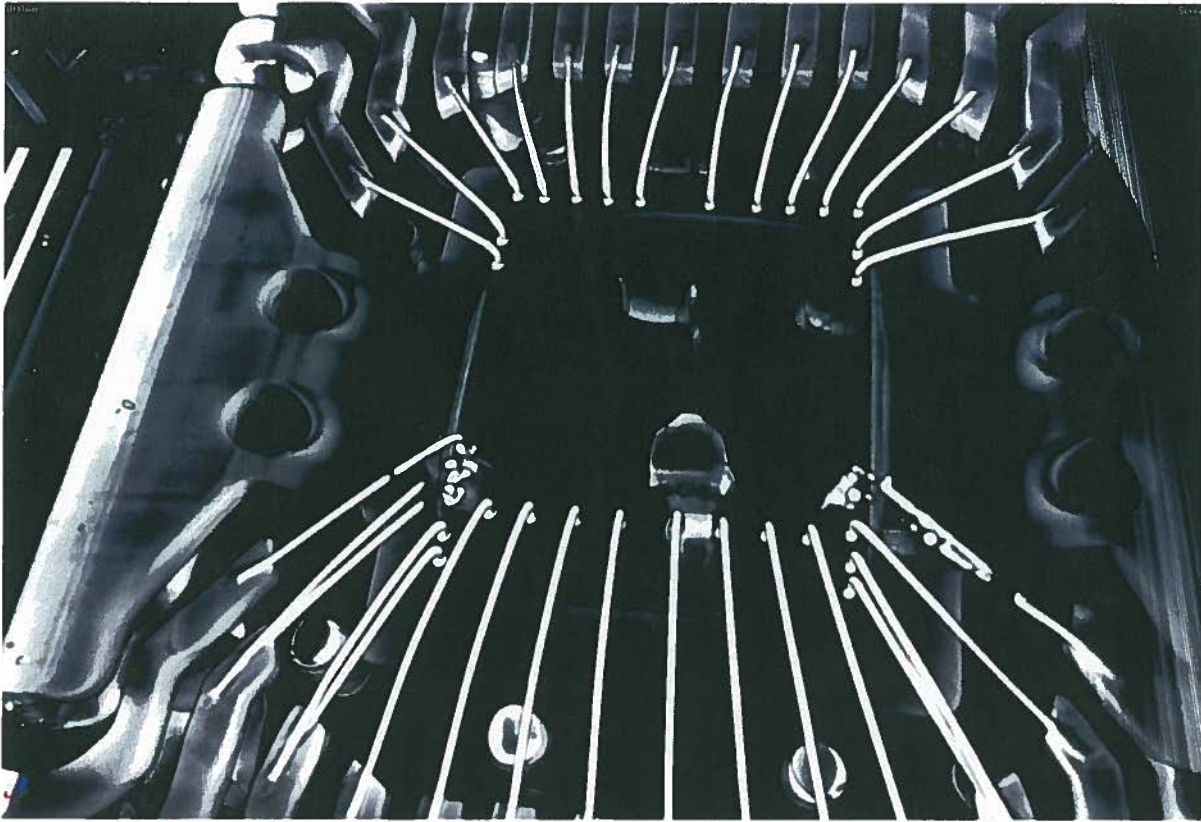
Photo 11 shows the two areas of interest, plus the other areas of bond wire interconnect on the IC. It is clear that the x-ray (photo 10) was capable of picking out and highlighting the area(s) of concern, with the CT reconstruction then verifying the damage.

Photo 11 – VG Reconstruction Of IC After CT Scan, Confirming Damaged Bond Wires

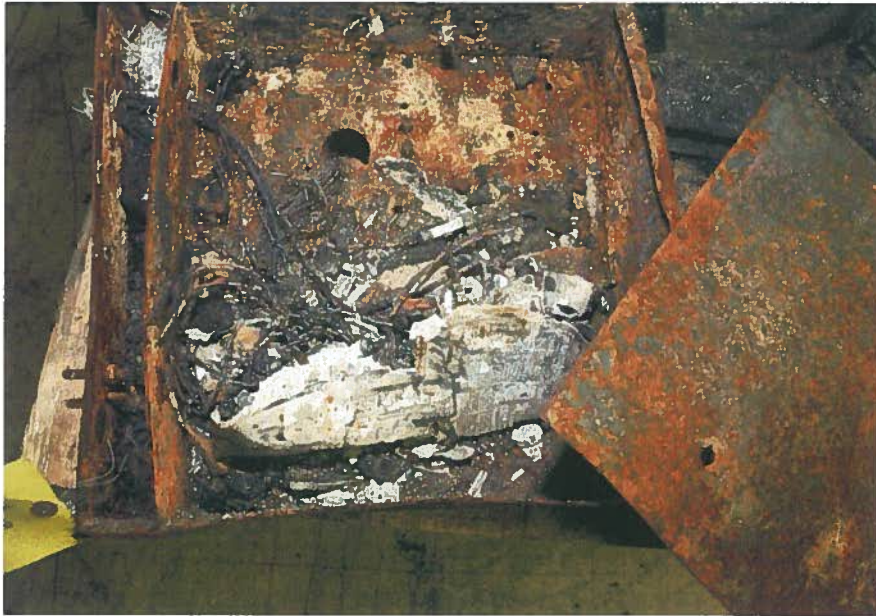
The PCB contained several LSI (Large Scale Integration) ICs. Each was x-rayed using a MF RT technique. Photo 12 shows the insides of the metal control cabinet and the various circuitry remains – the items are heavily damaged by heat.

Photo 12 – Internal Parts Of Hot Tub Controls

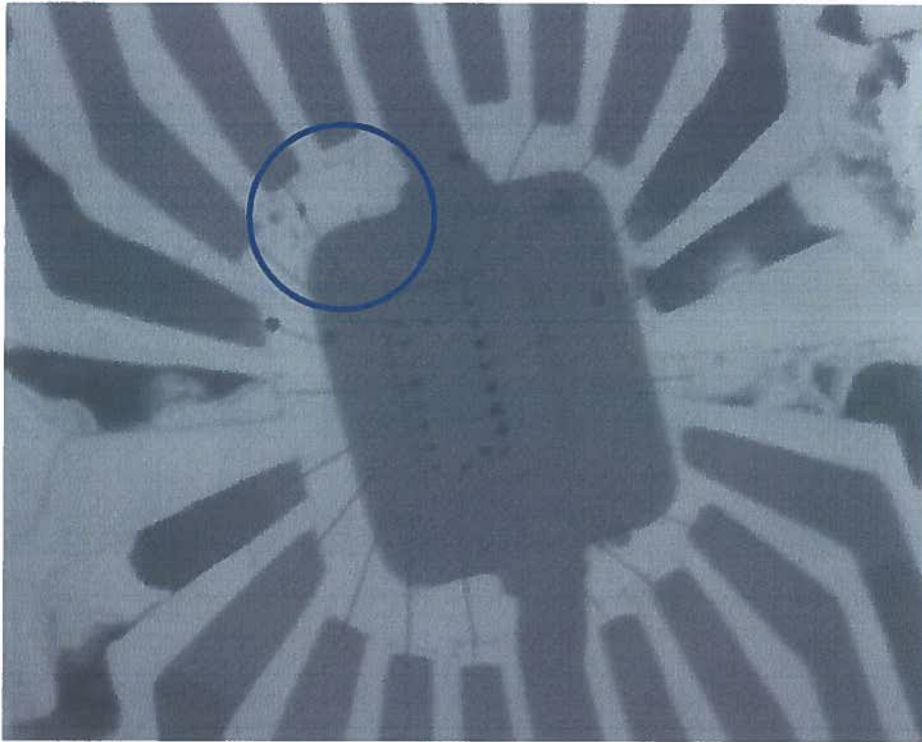
The x-rays of the ICs were examined. One IC had noticeable damage internally, as seen on photo 13. A check of the pinout for the IC verified that one of the leads of interest was a power lead (Vcc), and that it was partially vaporized.

Photo 13 – Circle Denotes Area Of Suspected Damage To Bond Wires

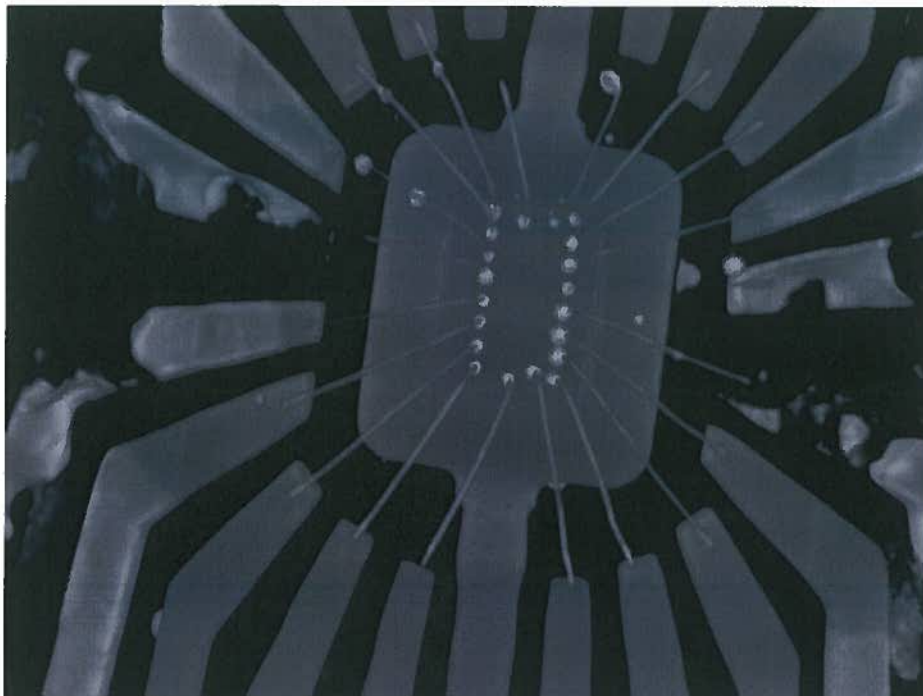
Photo 14 - Internally Damaged Bond Wires

The IC was subject to a CT scan, and the data then reconstructed. Photo 14 shows the internal layout of the same IC, after reconstruction. The Vcc lead was confirmed in terms of its evaporation. We also were

able to determine that 120 volts (or similar voltages) were present on the IC, based on damage to the pinout.
