# **ENERGIZED NEUTRAL EFFECTS ON CORRUGATED GAS SUPPLY LINES**

Kevin R. Davis, PE, CFEI, CVFI  
Goodson Engineering, Denton, TX  
and  
Michael Shuttlesworth, PE  
Goodson Engineering, Denton, TX

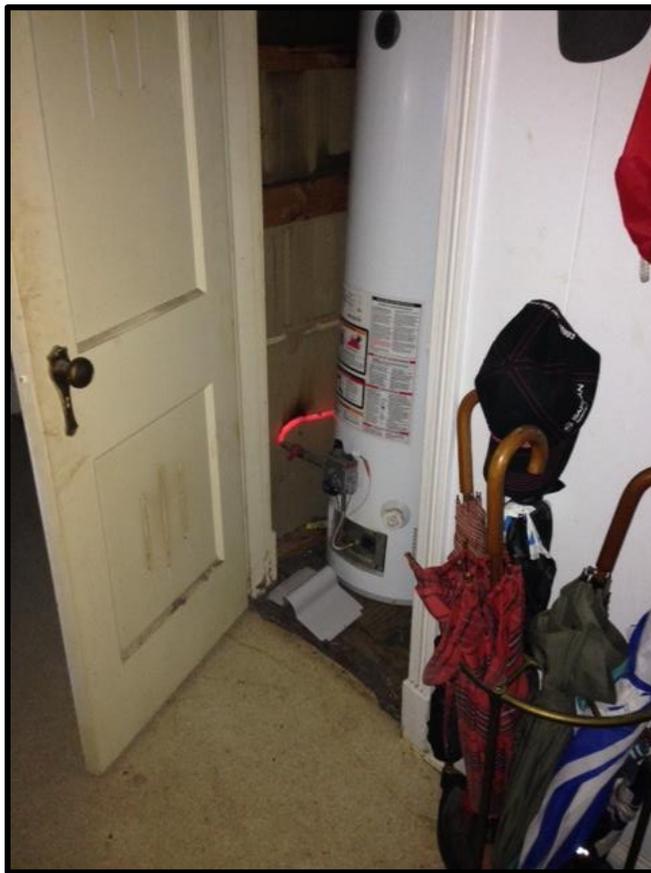
This paper will share what occurred during one particular instance where a home owner witnessed and photographed an energized neutral event. Fortunately, a fire did not occur, but easily could have. The home owner photographed the gas appliance connector connected to a water heater that was glowing red hot during the event.

**FIGURE 1: The Photograph Of The Glowing Gas Line. Photograph courtesy of Ms. Adams.**

By comparing the luminosity of the corrugated gas line as seen in the photo provided by Ms. Adams (FIGURE 1), we can estimate the current flowing through the gas line was approximately 125 – 135 amps. We can also estimate that the surface temperature of the corrugated gas tubing was approximately 1150°F – 1200°F. It was very fortunate that a fire did not occur at the home of Ms. Adams.

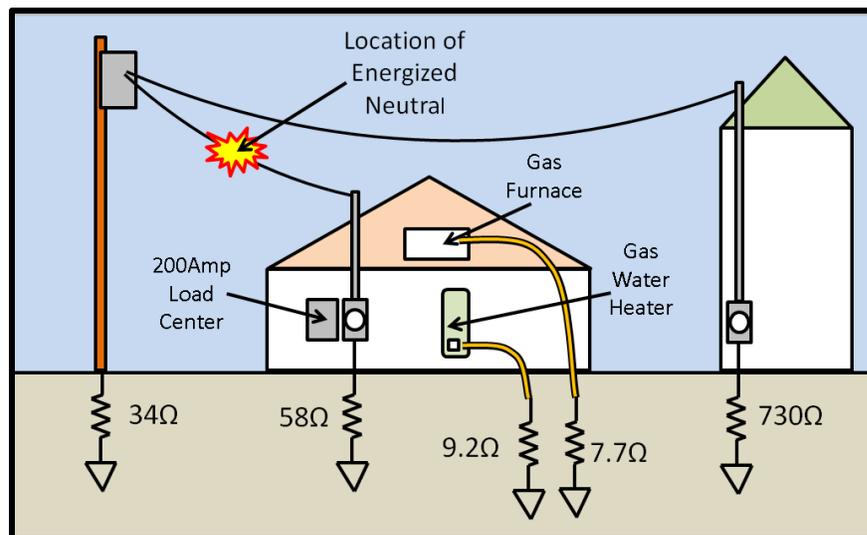
- Ground conductor at the utility pole ( $34\ \Omega$ ),
- Ground rod for the house ( $58\ \Omega$ ),
- Ground rod for the unattached garage/apartment ( $730\ \Omega$ ),
- Corrugated gas line on the furnace ( $7.7\ \Omega$ ),
- Corrugated gas line on the water heater ( $9.2\ \Omega$ ),
- Copper water line supply to the water heater ( $0.045\ \Omega$ ), and
- Copper water line for hot water ( $106\ \Omega$ ).

**FIGURE 2: Map Of Ground Resistance Measurements.**

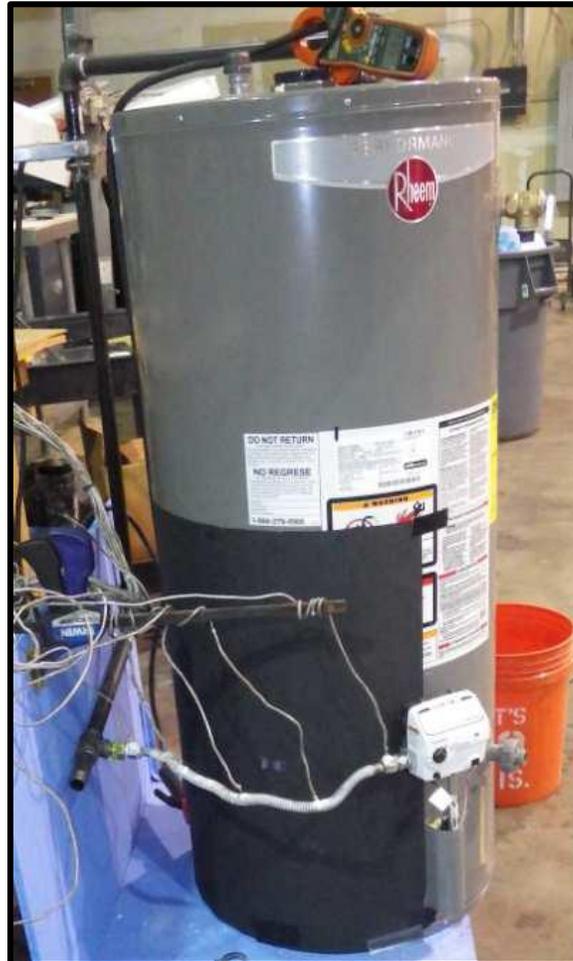
The yellow insulating coating was burned off of the gas line during the set up in order to affix the thermocouples directly to the metallic surface of the corrugated gas supply line (see Figure 3). The data from the thermocouples was collected using a Keithley, 2700 multimeter/data acquisition system. The current was monitored using an Extech True RMS AC/DC clamp meter, model EX830. The water heater was not connected to a supply of gas or water at any point during the testing.

**FIGURE 3: The Test Set-up. NOTE: The Water Heater Is Not Supplied Gas or Water.**

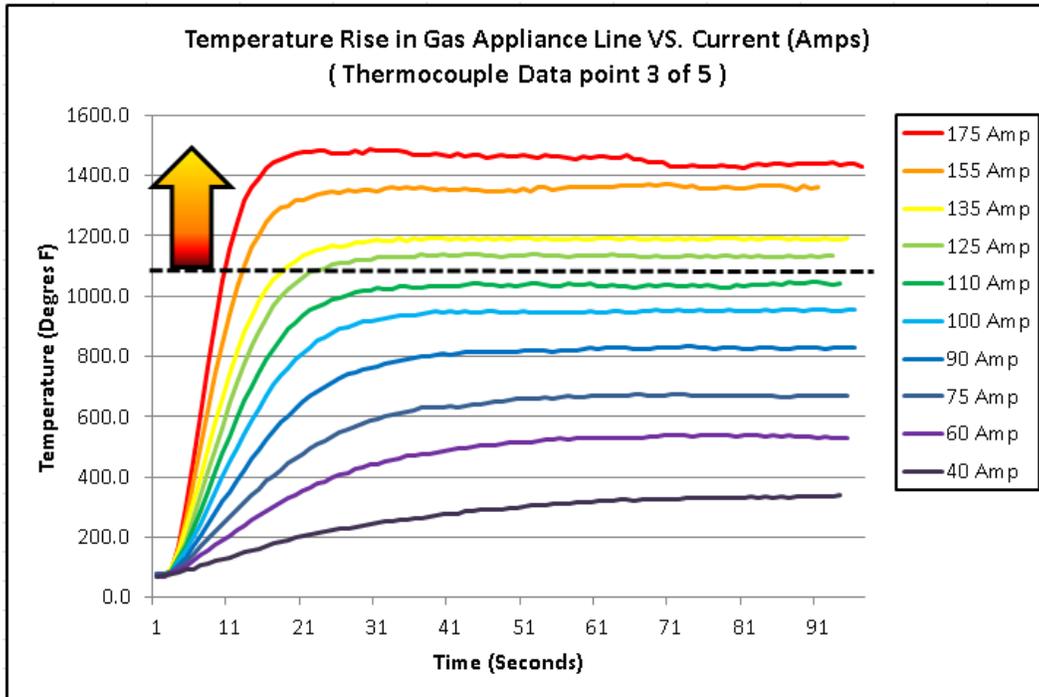
The test data has been represented in figures 4 and 5 below. The corrugated gas line could not be seen to glow until the surface temperature reached approximately 1100°F, as measured on the thermal camera. A current flow of 110 amps was required to observe a slight glow of the gas line. We noted that as the level of current increased, the brightness of the glow also increased, as well as, the maximum surface temperature of the corrugated gas line.

**FIGURE 4: Graph Of Current Vs. Time At Multiple Current Levels. NOTE: Dashed Line Indicates The Approximate Temperature When The Gas Line Begins To Glow.**

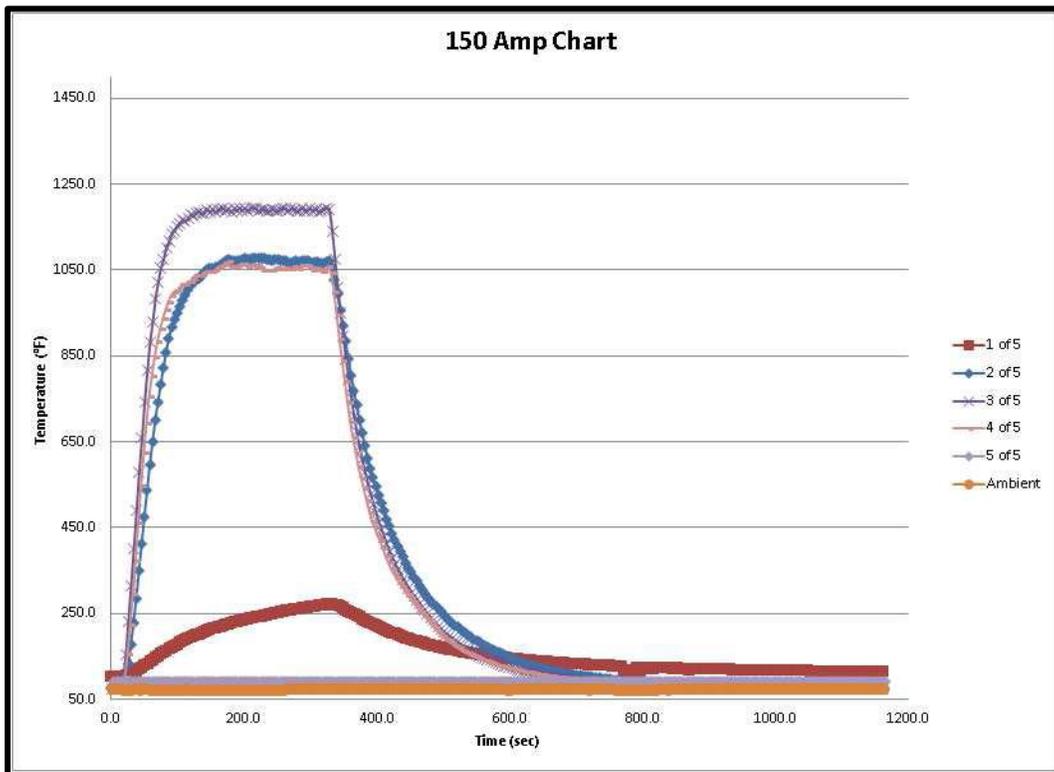
**FIGURE 5: Temperature Profile Along The Length Of The Gas Line Was Also Collected At Each Current Level. NOTE: The Thermocouple Located In The Center Of The Length Of Gas Line Reached The Highest Temperature. The  $T_{rise}$  and  $T_{fall}$  Times Were Short.**

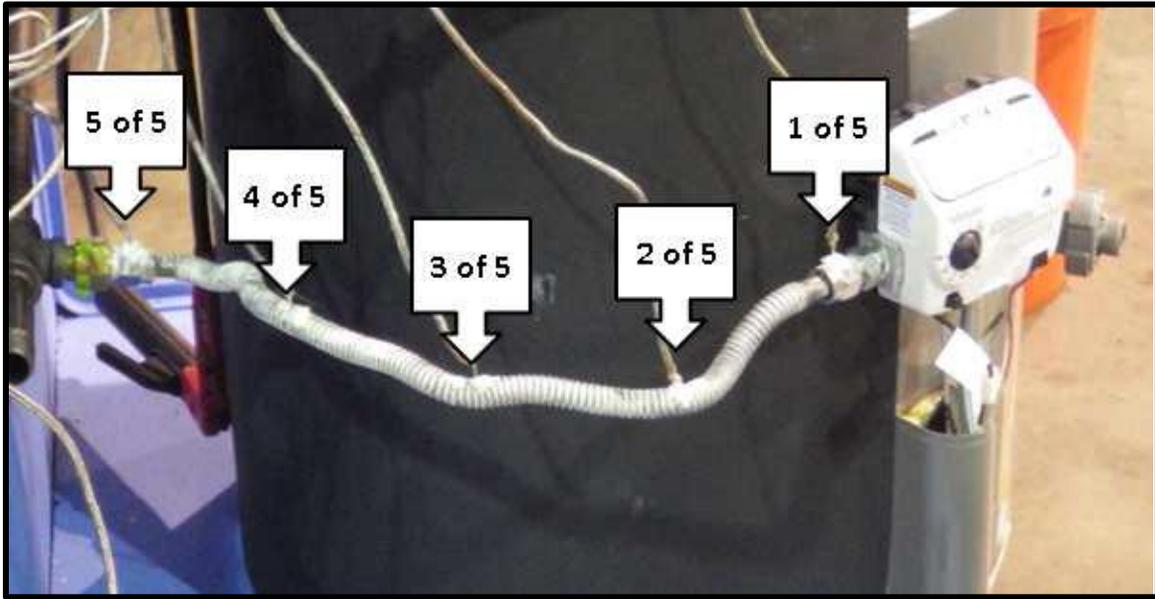
**FIGURE 6: Locations Of The Thermocouples On The Corrugated Gas Line And End Nuts.**

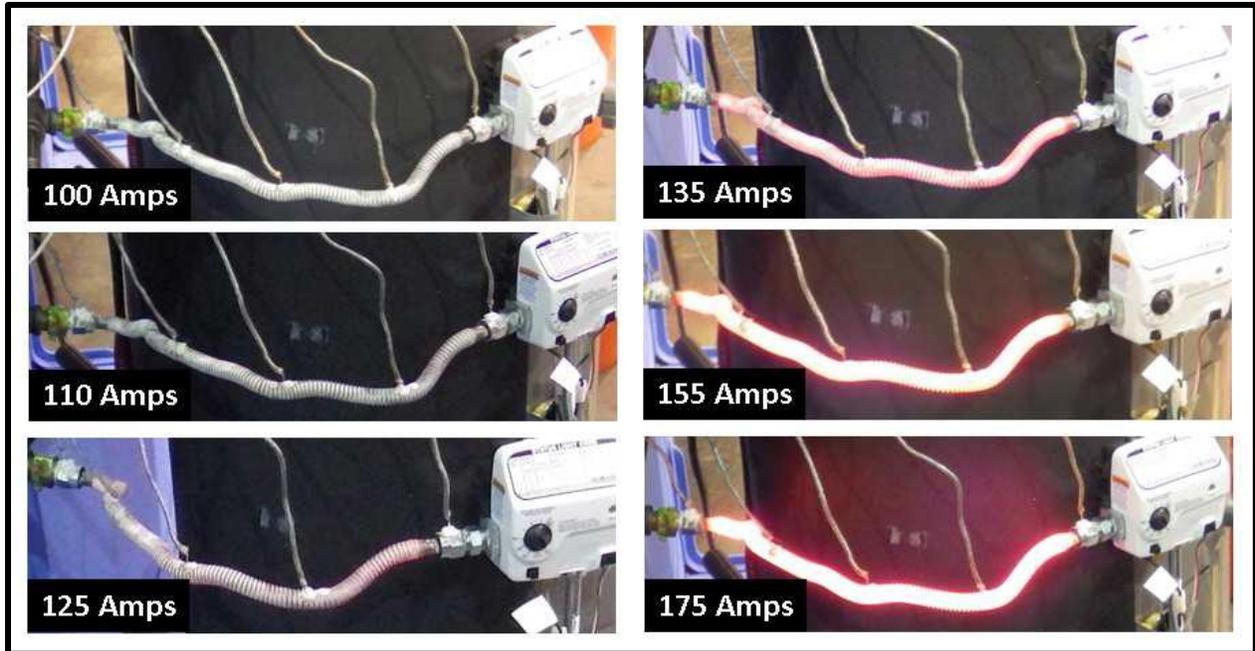
**FIGURE 7: Photographs Of The Luminosity Of The Gas Appliance Connection Vs. Current Flow.**
