INVESTIGATING THE CAUSAL LINK BETWEEN LIGHTNING STRIKES, CSST AND FIRE

Mark Goodson, PE and Mark Hergenrether, MSME

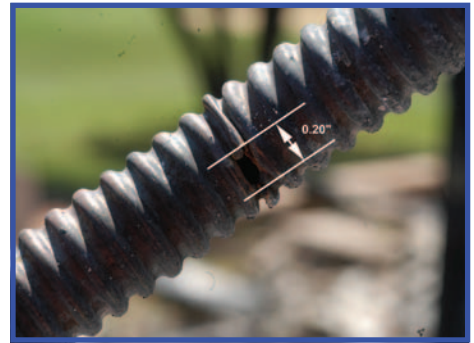
The fire occurred in a two story house under construction, plumbed with approximately 95 percent black pipe with a value in excess of \$1,000,000. Two runs of CSST, each serving a metal chimney, comprised the CSST piping in the house. A perforation with its major axis measuring approximately 200 mils was found in the CSST; this is shown in Figure 3. A positive lightning report was obtained, showing 11 strikes within 0.5 mile. Figure 4 shows the failed CSST run to the fireplace.

Figure 3: Perforated CSST pipe from fire in Edmond, Oklahoma.

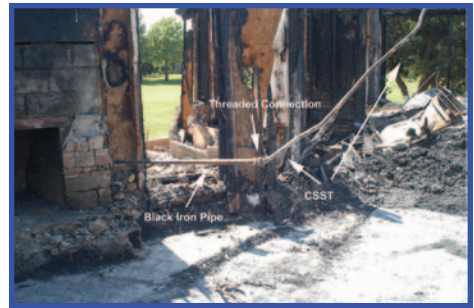
Figure 4: CSST tied to Black Iron pipe from fireplace.

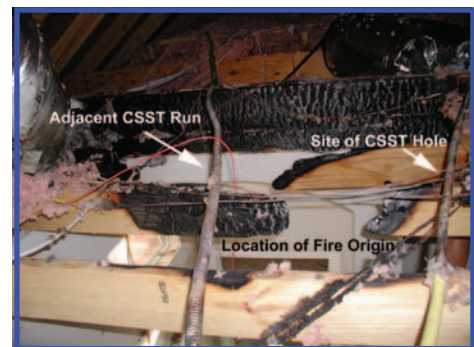
The fire occurred within the attic space of a home, which included several runs of CSST. The CSST runs went to a fireplace, furnace, range, and water heater. During a lightning storm, the CSST run serving the fireplace leaked and the resultant fire then destroyed a section of the attic. A perforation measuring 95 mils along its major diameter was found in the pipe. A lightning report showed that there were approximately 5 strikes within 0.3 mile of the house. The fire was contained within the attic, but subjected the house to extensive smoke damage. Figure 5 shows the burned section of the attic as a result of the fire that occurred during the lightning storm. Figure 6 shows a view of the arc site and adjacent hole in the CSST pipe. An even closer inspection of this same hole when viewed under a Scanning Electron Microscope (SEM) is shown in Figure 7. SEM/EDS (Energy Dispersive X-ray) analysis was negative for aluminum or other indicators of eutectic melting.

Figure 5: Attic fire during lightning storm Cedar Hill, Texas.

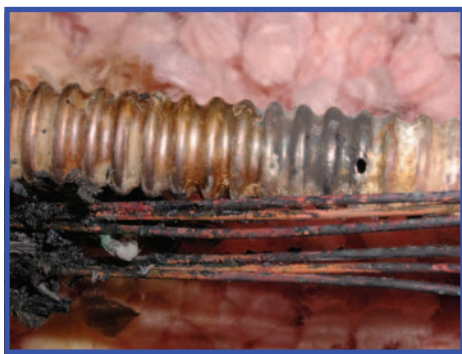
Figure 6: Arc Hole in CSST.

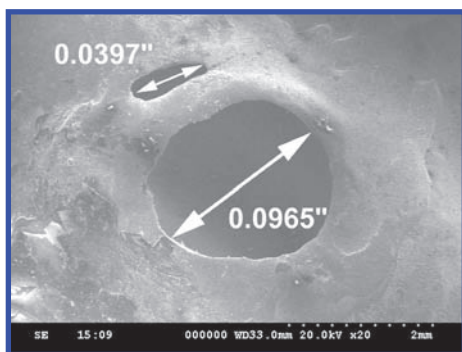
Figure 7: Arc Holes in CSST induced by lightning magnified 20X under SEM.

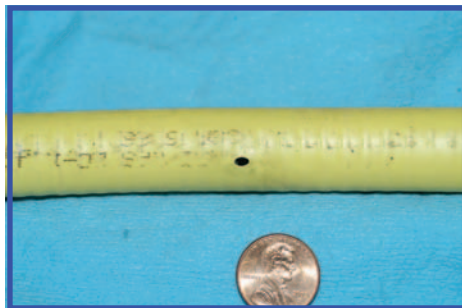
Figure 8: Photo of perforated CSST without pyrolysis.

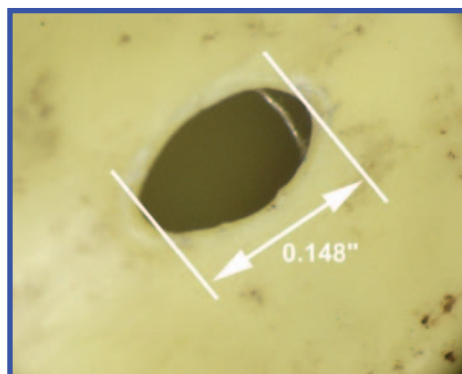
Figure 9: Microscopic View of Perforated CSST.

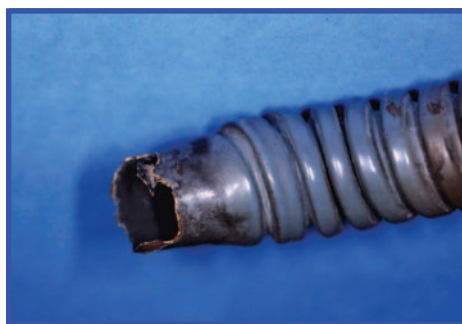
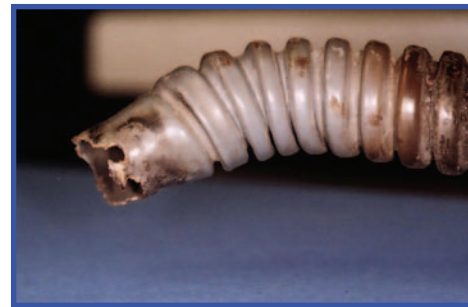
The Frisco Fire Department Report lists escaping gas from the end connectors during lightning events as also being possible sources of the fire's cause. In a previous article written by one of the authors (MEG), this very phenomenon was described on appliance connectors.^[19] The fact that a gas line fails at a connection is no surprise, in that gas lines are chosen for mechanical integrity at their junctions, and not necessarily electrical conductivity. Figure 10 shows the end of a failed appliance connector that has failed with resultant arcing and thus caused a fire due to electrical current flow. We might expect to see similar manifestations with CSST at its connectors.

Figures 10a & 10b: Bottom and side respective views of failed gas line from appliance connectors (Not CSST).

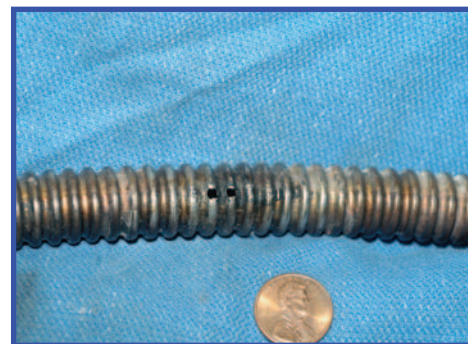
Figure 11 shows a length of CSST in which there were two perforations in adjacent furrows of the tubing. We have seen as many as 4 holes in one CSST length after a fire. SEM / EDS analysis was negative for 'foreign' metals.

Figure 11: Adjacent perforations in CSST.
