INVESTIGATING THE CAUSAL LINK BETWEEN LIGHTNING STRIKES, CSST AND FIRE

Mark Goodson, PE and Mark Hergenrether, MSME

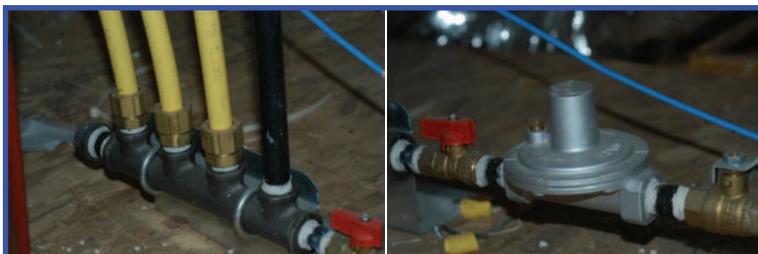
Figure 1: Manifold and Regulator Leads of CSST Setup.

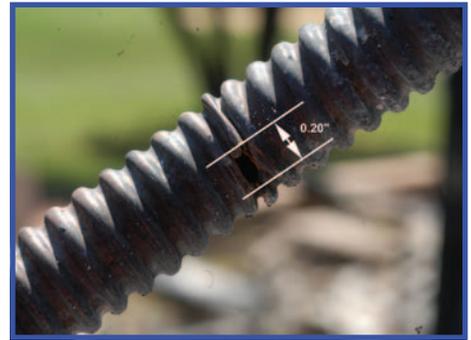
The fire occurred in a two story house under construction, plumbed with approximately 95 percent black pipe with a value in excess of \$1,000,000. Two runs of CSST, each serving a metal chimney, comprised the CSST piping in the house. A perforation with its major axis measuring approximately 200 mils was found in the CSST; this is shown in Figure 3. A positive lightning report was obtained, showing 11 strikes within 0.5 mile. Figure 4 shows the failed CSST run to the fireplace.

Figure 3: Perforated CSST pipe from fire in Edmond, Oklahoma.

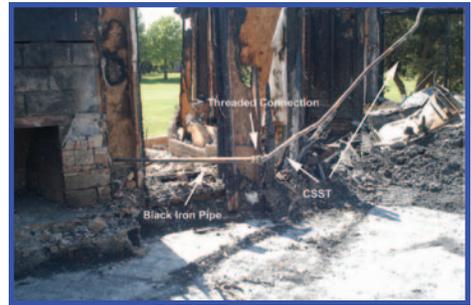
Figure 4: CSST tied to Black Iron pipe from fireplace.

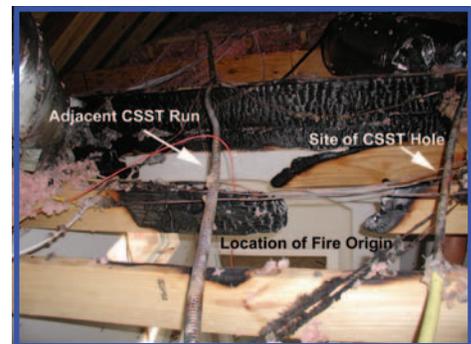
The fire occurred within the attic space of a home, which included several runs of CSST. The CSST runs went to a fireplace, furnace, range, and water heater. During a lightning storm, the CSST run serving the fireplace leaked and the resultant fire then destroyed a section of the attic. A perforation measuring 95 mils along its major diameter was found in the pipe. A lightning report showed that there were approximately 5 strikes within 0.3 mile of the house. The fire was contained within the attic, but subjected the house to extensive smoke damage. Figure 5 shows the burned section of the attic as a result of the fire that occurred during the lightning storm. Figure 6 shows a view of the arc site and adjacent hole in the CSST pipe. An even closer inspection of this same hole when viewed under a Scanning Electron Microscope (SEM) is shown in Figure 7. SEM/EDS (Energy Dispersive X-ray) analysis was negative for aluminum or other indicators of eutectic melting.

Figure 5: Attic fire during lightning storm Cedar Hill, Texas.

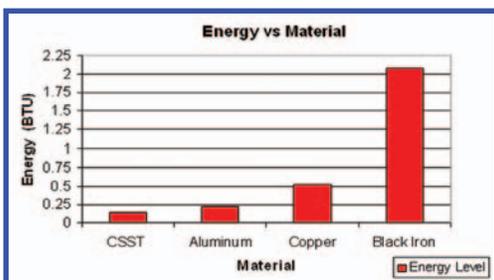
For an equivalent 100-mil diameter hole, we can calculate the values for heat capacity based on the aforementioned equation. Figure 2 is a plot of the respective values for each material. The amount of energy to create a 100-mil diameter hole is much greater for black iron pipe than for any of the

other three specimens. Thus, the thickness of the black pipe is critical to prevent fires post lightning strike. In fact for this particular case, the amount of energy required to melt conventional 1/2" black pipe is about 15 times that which would be required to similarly melt CSST.

Figure 2: Comparison of heat capacity for 100 mil diameter hole in CSST, Aluminum, Copper & Black Iron.

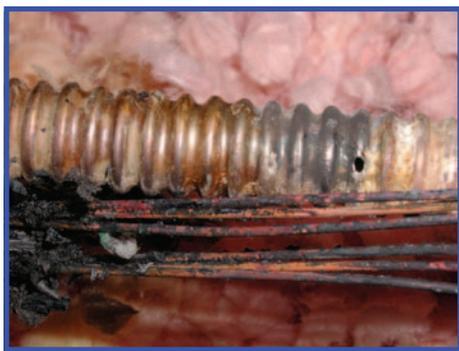
Figure 6: Arc Hole in CSST.

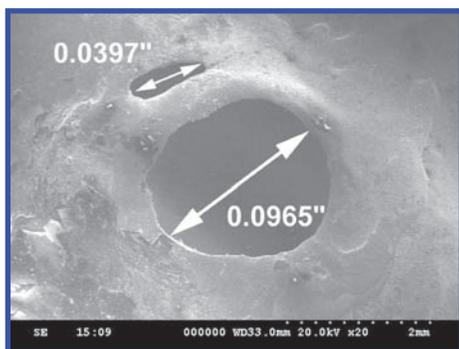
Figure 7: Arc Holes in CSST induced by lightning magnified 20X under SEM.

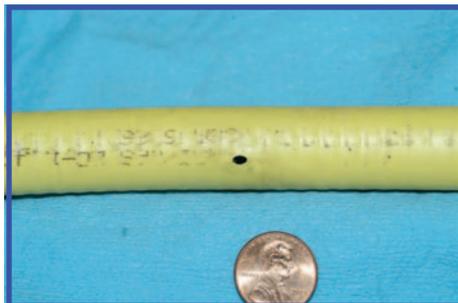
Figure 8: Photo of perforated CSST without pyrolysis.

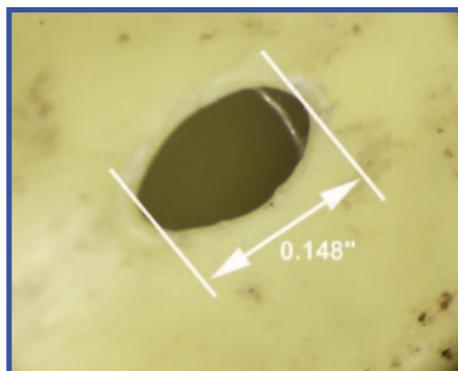
Figure 9: Microscopic View of Perforated CSST.

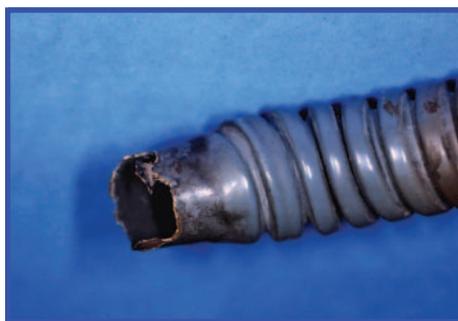
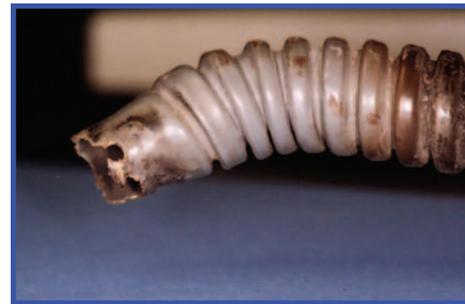
Figures 10b.

The Frisco Fire Department Report lists escaping gas from the end connectors during lightning events as also being possible sources of the fire's cause. In a previous article written by one of the authors (MEG), this very phenomenon was described on appliance connectors.^[19] The fact that a gas line fails at a connection is no surprise, in that gas lines are chosen for mechanical integrity at their junctions, and not necessarily electrical conductivity. Figure 10 shows the end of a failed appliance connector that has failed with resultant arcing and thus caused a fire due to electrical current flow. We might expect to see similar manifestations with CSST at its connectors.

Figures 10a & 10b: Bottom and side respective views of failed gas line from appliance connectors (Not CSST).

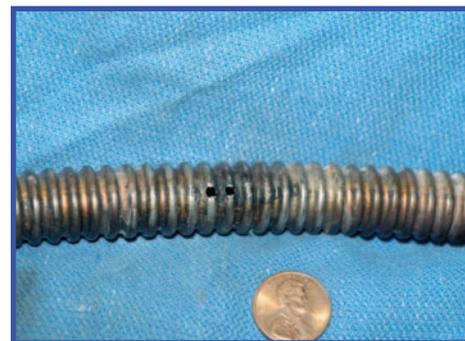
Figure 11 shows a length of CSST in which there were two perforations in adjacent furrows of the tubing. We have seen as many as 4 holes in one CSST length after a fire. SEM / EDS analysis was negative for 'foreign' metals.

Figure 11: Adjacent perforations in CSST.
