FIRE & INVESTIGATOR

JOURNAL OF THE INTERNATIONAL ASSOCIATION OF ARSON INVESTIGATORS, INC.

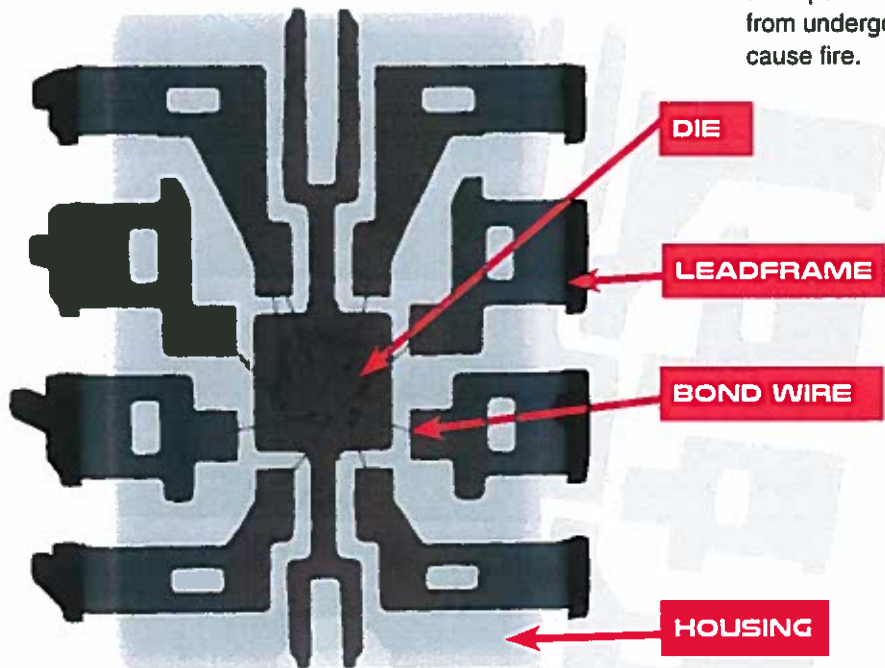
PHOTO 2 - X-ray View of IC, LM386 Audio Amplifier with Top Level Components Illustrated.

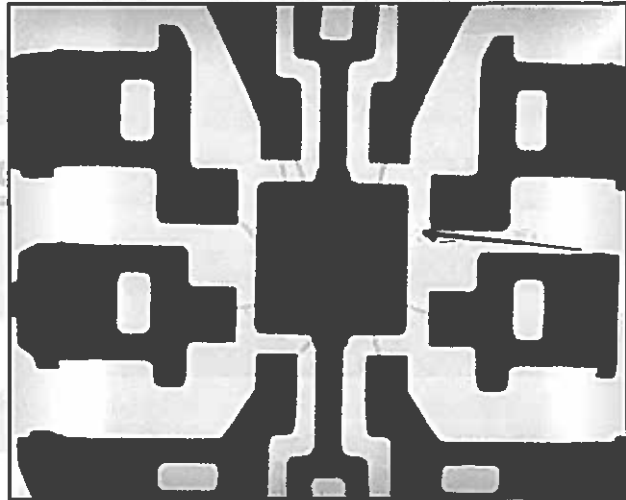
PHOTO 3 - Non-Continuous Bond Wire, Pin 6 of Leadframe to Die.

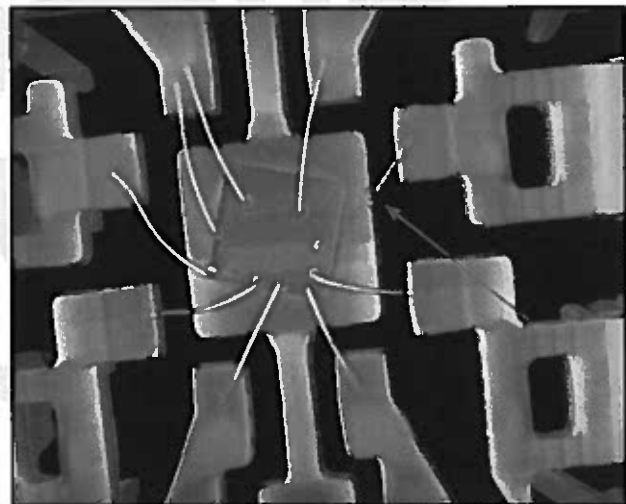
PHOTO 4 - Reconstructed CT Image, Showing Electrical Damage on Wire to Pin 6.

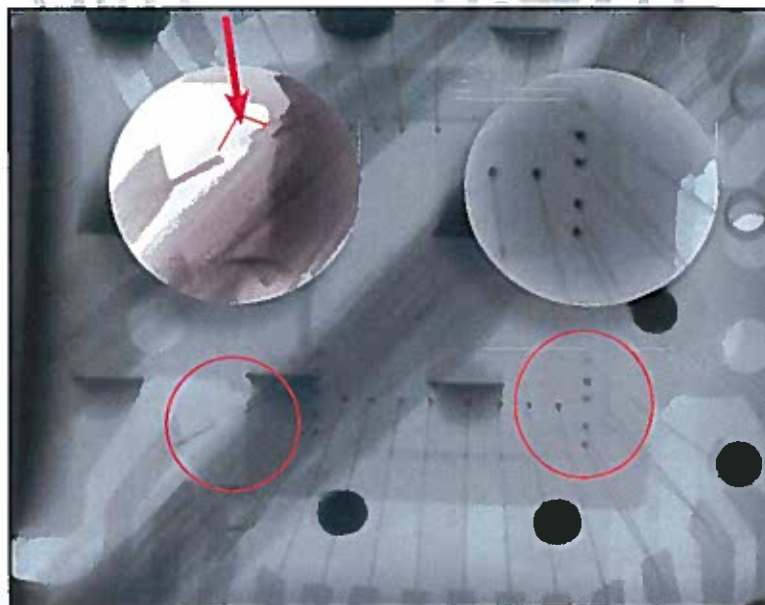
PHOTO 5 - Microfocus X-ray of Integrated Circuit from Burned DVD Player. The Two Red Circles Denote Areas Where Damage to Bond Wires Was Apparent.

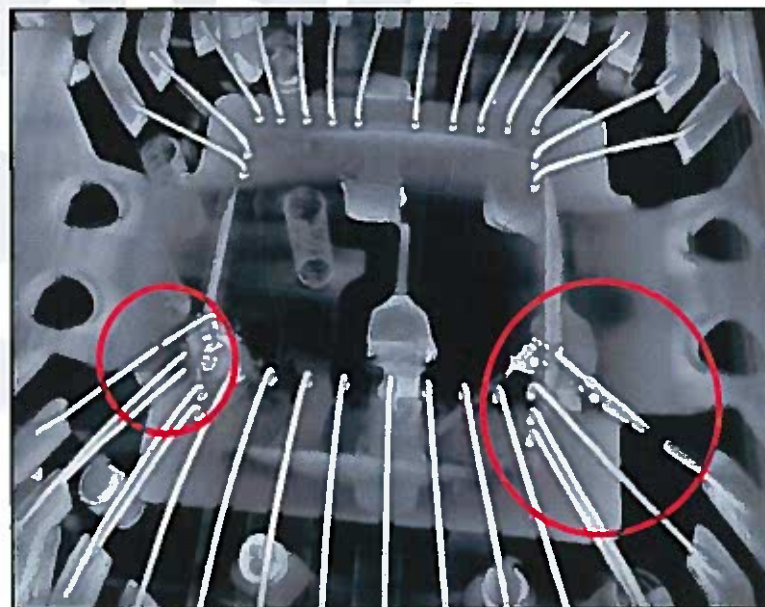
PHOTO 6 - Reconstructed 3-D Image of Internal Bond Wires Within IC, Corresponding to Damage Noted from Photo 5 X-ray.

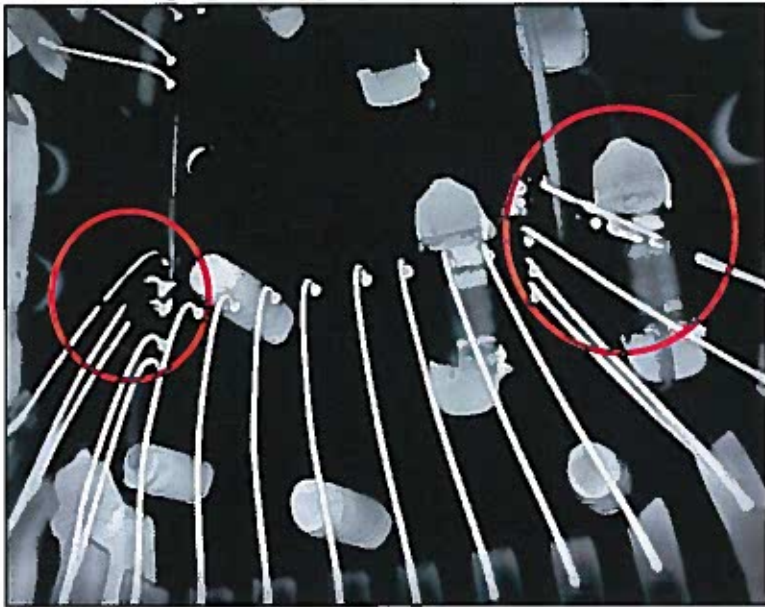
PHOTO 7 - Different View of Reconstructed Failed IC Bond Wires from Fire Damaged DVD.

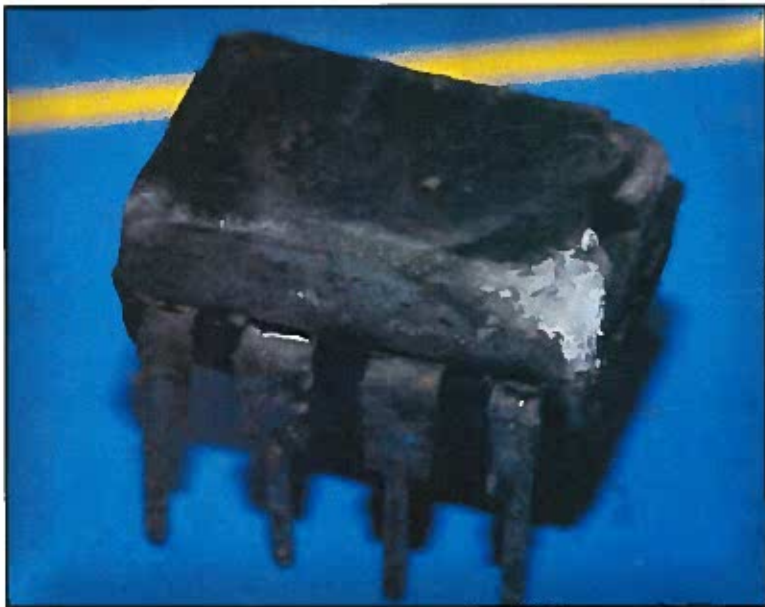
PHOTO 8 - Charred LM386 Integrated Circuit.

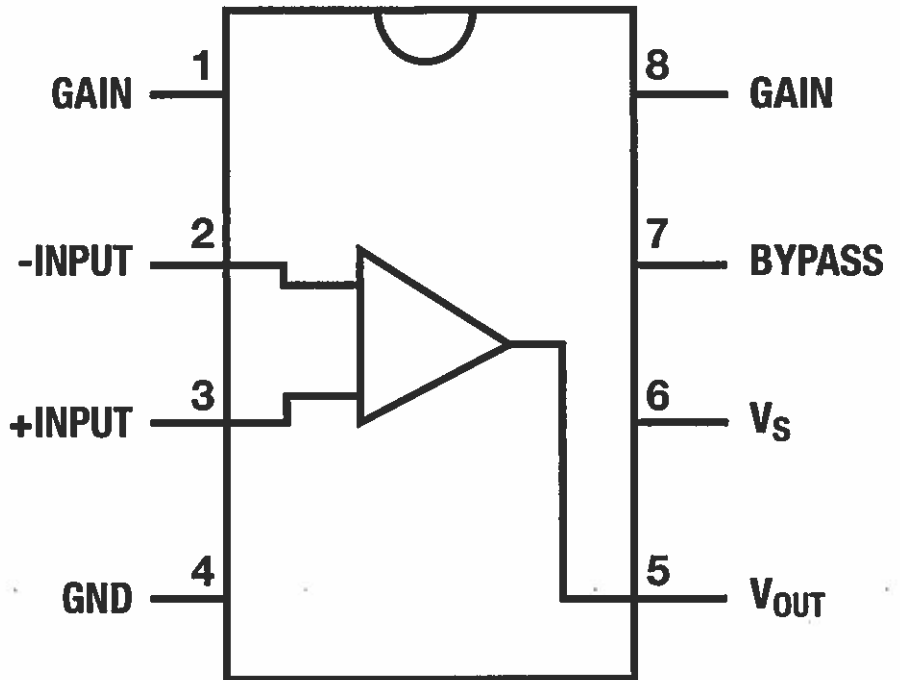
FIGURE 1
Schematic Pinout of LM386.

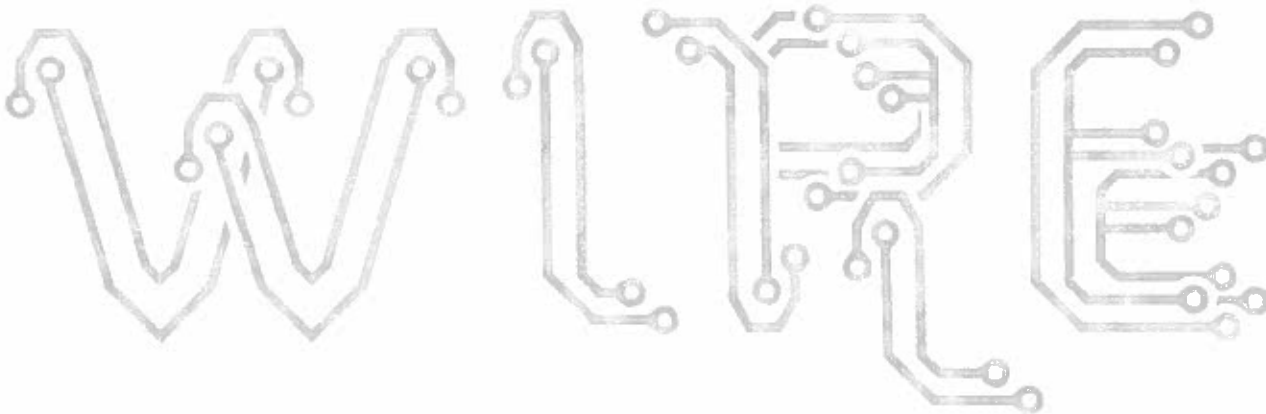
Consequently, pins 4, 5, and 6 are where large amounts of current might flow, relative to the other five pins. We also note from the X-ray and CT that pin 4 uses two bond wires. By applying Kirchoff's Current Law, and knowing that for our testing with 40 volts that current entered and left by pins 6 and 4, respectively, the current on the two bond wires associated with pin 4 are half the current density J as that on pin 6. When an overcurrent situation exists on the LM386 IC, one would reasonably expect damage to bond wires on pins 5 and 6.

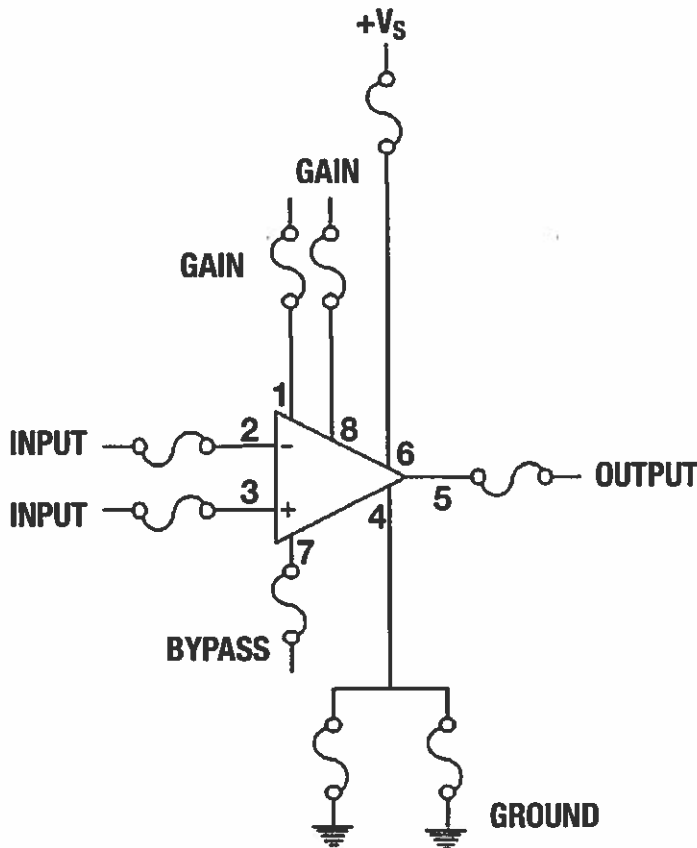
FIGURE 2
9 Bond Wires Added for 8 Pins
(Pin 4 Has Double Bond Wires).
