DENTON, TEXAS—During the last six years, the authors have procured and/or participated in many lab examinations where CSST was suspected of having been involved in a fire. Over this time period, a systematic protocol has been developed for inspecting such CSST.

TECHNIQUES

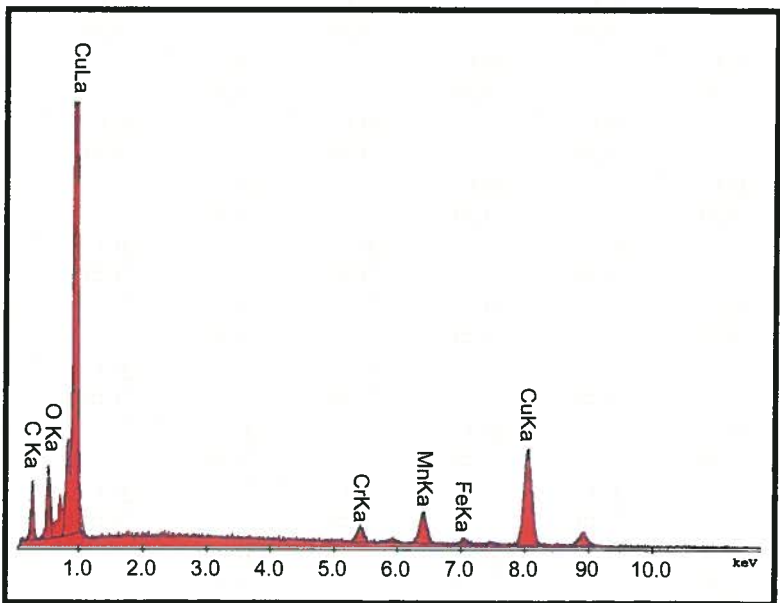
FIGURE 1

The spectra of the flowing material surrounding the hole in Photo 4.

The melted material on the exterior edge of a CSST hole. It was found to contain Cu (copper), according to the spectra in Figure 1.

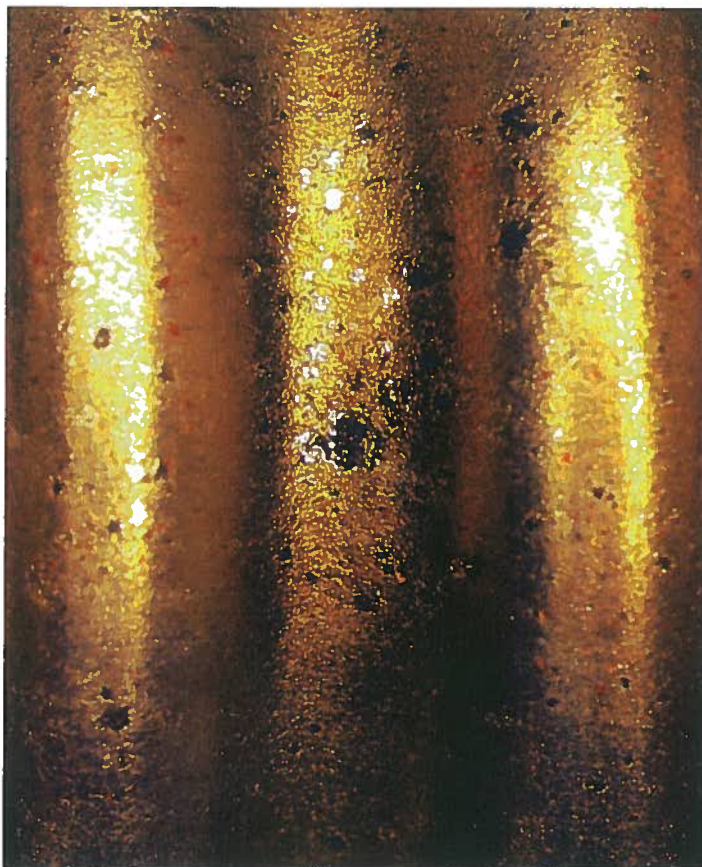
PHOTO 3

View of spatter on opposing interior wall of same CSST hole

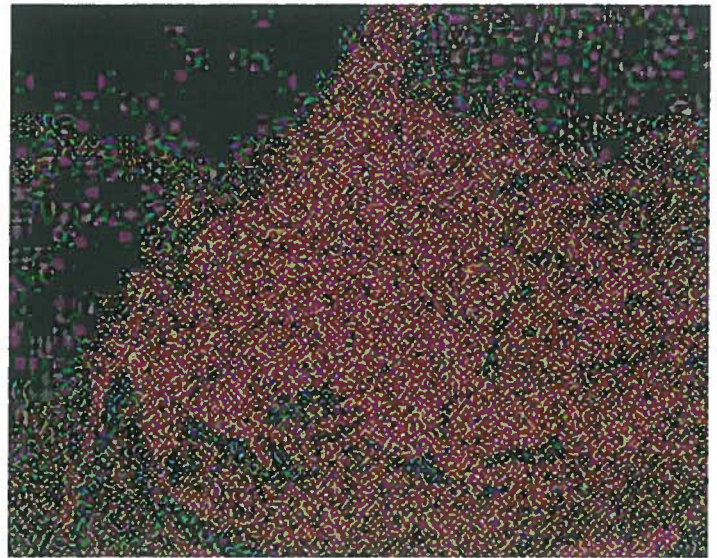
PHOTO 6

EDX map highlighting copper in region surrounding the hole in Photo 4.
