Rope Light FIRES

Mark Goodson, PE
 Tony Perryman, PE
 Mark Hergenrether, MSME
 Kelly Colwell, MASTER ELECTRICIAN

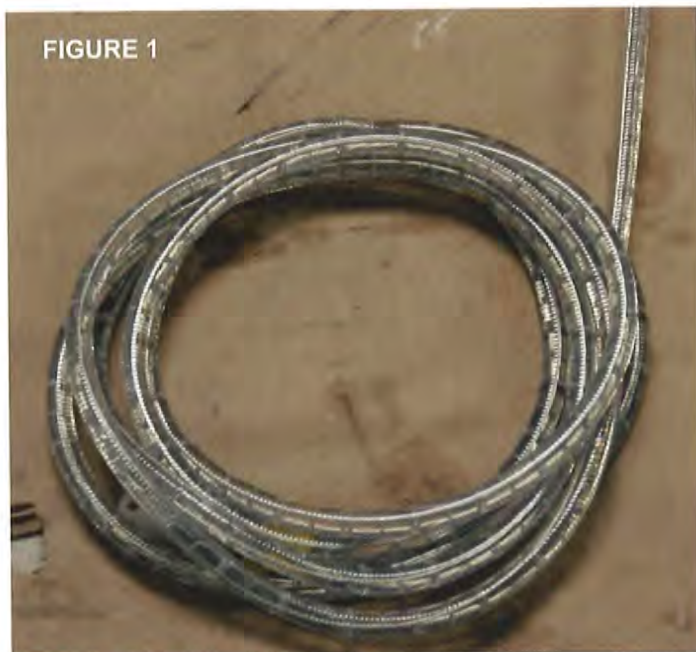
FIGURE 1

Rope lights have become a popular alternative for landscapers, decorators, and individuals looking for a lighting source that can provide a chic appearance without the economic impact. The flexible construction of rope lights (Figure 1), allows them to be effectively installed in hard to reach places without large labor costs. While they bolster the luminance of an area, the lights are not without hidden dangers. During the last several years, our lab has been consulted on multiple occasions in regards to fires believed to be caused by ROPE LIGHTING.

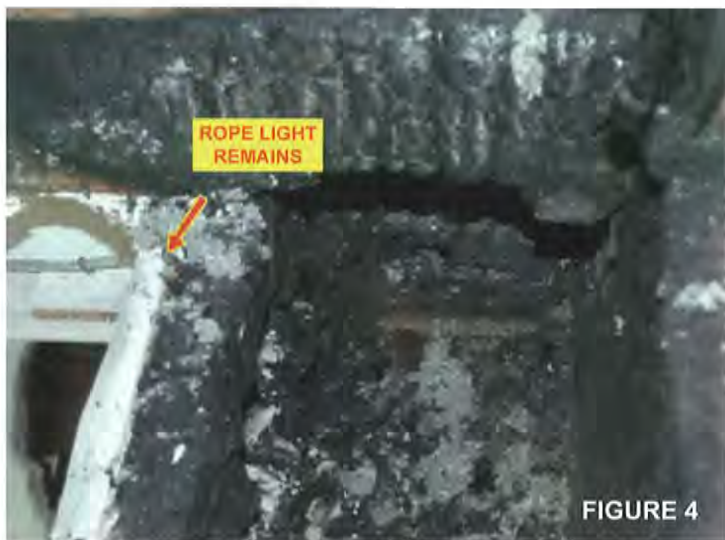
FIGURE 4

1. The fire occurred in a ~ 4 ft x 4 ft (1.2 m x 1.2 m) square cove at ceiling level, with a 20 ft (6.1 m) rope light. The extra 4 ft (1.2 m) of rope had been thrown in the attic and insulated over with cellulose insulation. An indoor residential fire sprinkler pipe was nearby, and ruptured from heat of the fire, extinguishing the fire. Examination of the rope lights in other coves showed that there was browning of the cellulose insulation. The male plug (blades) had been cut off and removed, as had the in line fuse holder; the rope light was hard wired in place. Watt density was 3 watts per foot (9.8 W/m) for the rope light (Figure 4).

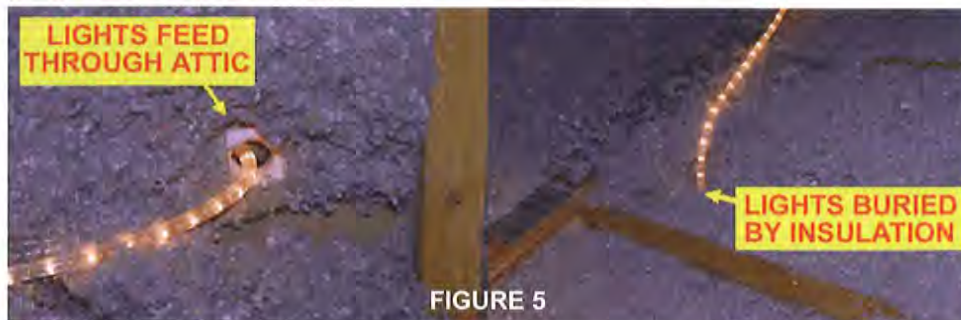
FIGURE 5

2. The fire occurred in the attic space above a bathroom. The attic space was adjacent to a bedroom with a tray ceiling. The rope light was installed in the shelf around the base of the ceiling. An extra 16 ft (4.9 m) of the rope light had been discarded in the attic and subse-

quently insulated over. The watt density of the light was 5.5 watts per foot. Inspection of the rope light revealed that it had been directly wired into a switch in the bedroom. There were no in-line fuses installed along its length (Figure 5).

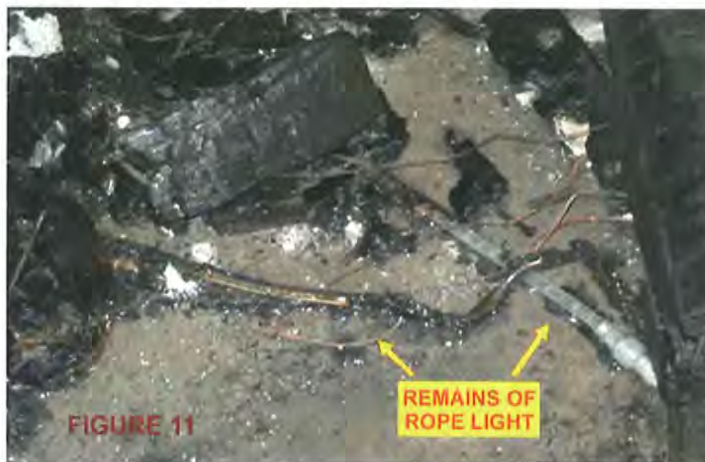
FIGURE 11

the ambient. The strings were supplied 120 VAC for 8 hours and the temperatures were monitored. At the end of the test the voltages were removed from the strings and the temperatures were examined. The temperatures on the 3 W/ft string had reached just over 700°F (371°C) (Figure 10). The temperatures for the 2 W/ft string reached over 325°F (162°C). At this time the box was emitting strong odors, most likely from charring on the insulation. Several hours thereafter, the box itself ignited and burned the testing table (Figure 11).
