HIDDEN DANGERS OF HALOGEN LIGHT FIXTURES

Co-authored by—Mark E. Goodson, PE; Kelly Colwell; Tony Perryman, EIT; Dave Sneed, CFI

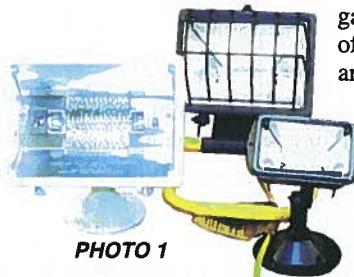
PHOTO 1

Several new fixtures were purchased, in both a work light configuration and fixtures meant for permanent mounting. (*Photo 1*) We noted that the two “permanent” fixtures (rated at 150 and 500 watts) were not intrinsically tight or intrinsically rated. They are listed for use in wet locations, however. On the work light (rated 500 watts), there was a gasket around the glass shield and also around the switch compartment giving some appearance of being intrinsically safe. A pilot hole was drilled in the body, and air pressure applied. We noted that despite the gaskets, the work light is not airtight—air leaked out at the

gaskets and at the switch cavity. Thus, none of the fixtures we examined were airtight, and all would be conducive to igniting atmospheres that are within limits of explosivity and which have auto ignition temperatures of approximately 1200° F. or less.

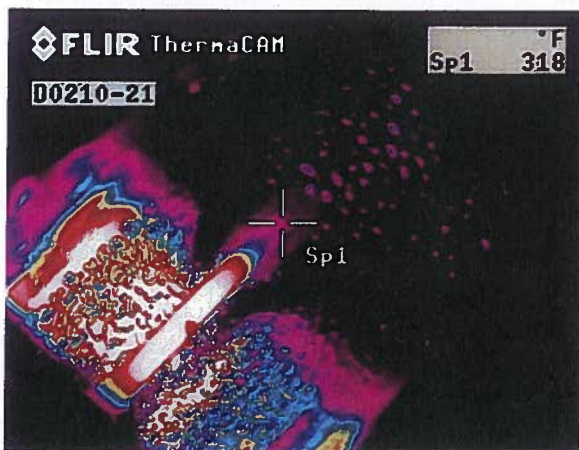
We also examined the 500 watt work light with an infrared camera, FLIR/AGEMA 595. The thermogram is shown as photo 2. The Spot Temperature (*Sp 1*) was measured at 318° F; its importance will soon become apparent. The second thermogram (*Photo 3*) shows bulb envelope temperature at two different points (*Sp 1 and Sp 2*). The temperatures are 1239 and 1255° F, respectively. These temperatures are approximate measurements.

(PHOTO 2)—Thermogram of a 500 watt work light. The Spot Temperature (Sp 1) was measured at 318° F.

An additional hazard, which is even more obscure, is that of arcing contacts. It is difficult to design an inexpensive, mass production light fixture where the electrical contact temperature for the bulbs will run several hundred degrees. In the thermogram, we noted a contact temperature of 318° F; which was also verified with a 30 AWG type K thermocouple. The gradient from bulb temperature (nominal 1255° F, to contact temperature 1255° F, is 932° F. This gradient is achieved in less than 1 inch. The high working temperature for the electrical contact, the gradient, and the high excursion temperature for the bulb envelope led us to suspect that the electrical contacts may be prone to arcing.

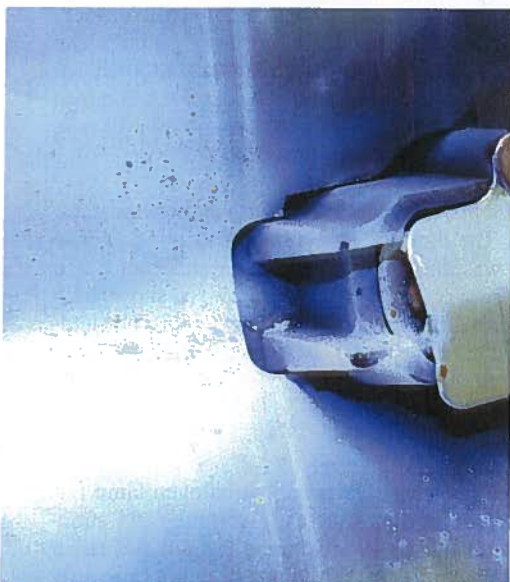
Photo 4 shows the copper splatter associated with a 300 watt fixture; the contact at the right end of the fixture was beginning to arc, spewing off molten copper. Photo 5 is a microscopic view of the end of a contact of a 500 watt fixture. As is obvious from these photos, the contacts can and do arc. While the arc by-products (splattering copper)

(PHOTO 4)—Shows a contact at the right end of a 300 watt fixture beginning to arc, spewing off molten copper.

will be contained by the glass shield, the arc is once again capable of igniting volatile atmospheres.

Given the measurements and documentation done as part of this study, a halogen light fixture has the propensity to ignite volatile atmospheres by way of actual heat or by arcing. Hence, these types of lights should never be used without the glass shield and they should not be used in volatile environments.

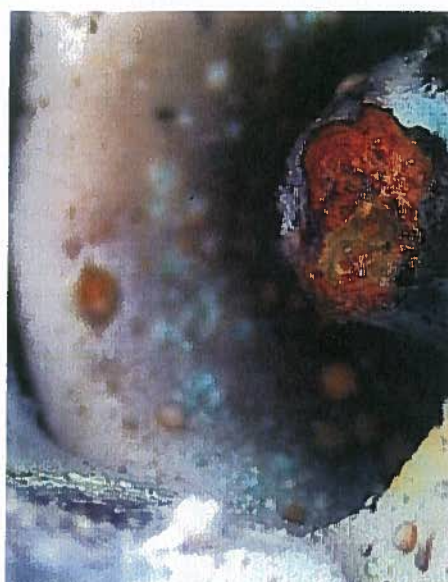
(PHOTO 5)—Microscopic view of the end of a contact of a 500 watt fixture showing arc by-products.
