# LOSS INVESTIGATIONS INVOLVING HEATING ELEMENT FAILURES: FIRE, WATER AND PERSONAL INJURY

Lee Green P.E. and Michael Shuttlesworth, P.E.  
GOODSON ENGINEERING, USA

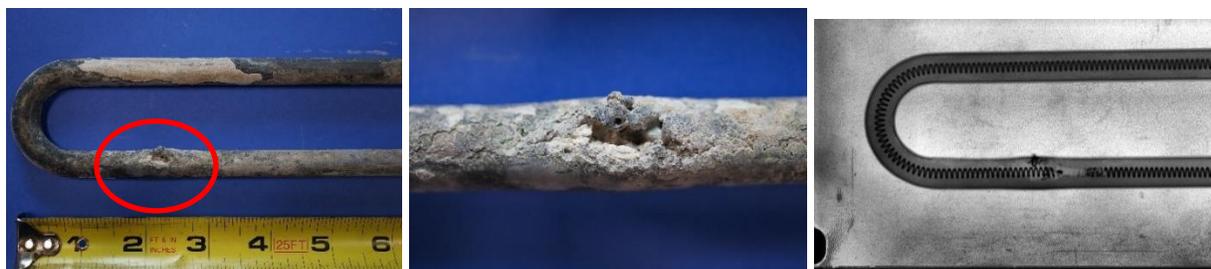
*Figure 2 Localized breach in sheath of titanium sheathed process heater.*

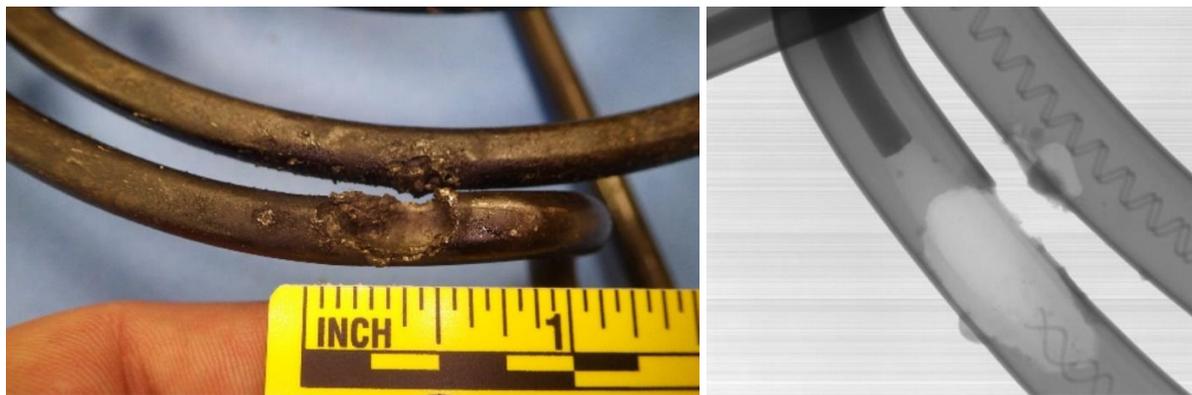
Figure 5 Failure of stove top heating element at cold pin

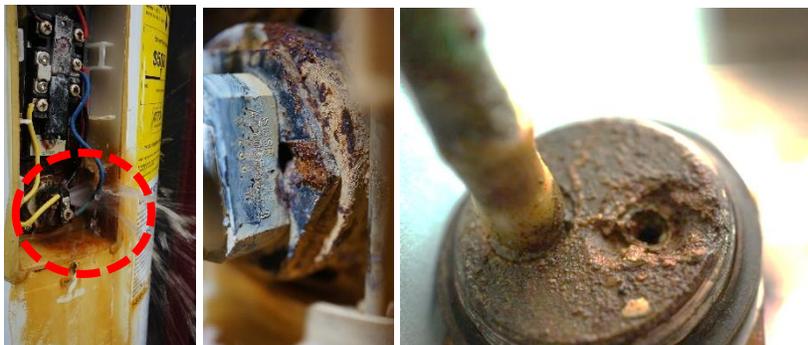
Figure 6 Failure of water heater element leading to breach in screw plug and release of water.
