Journal of the
National
Academy OF
Forensic
Engineers[®]

Vol. 38 No. 1 June 2021

State of the Arc (Mapping)

By David J. Icove, PhD, PE, DFE (NAFE 899F), Elizabeth C. Buc, PhD, PE, Mark E. Goodson, PE, and Thomas R. May, JD, Esq.

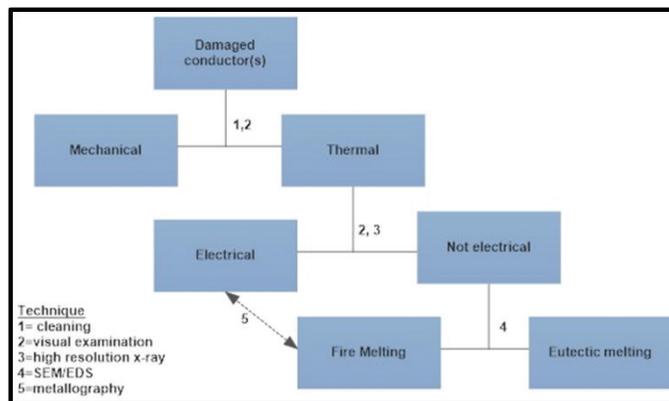
Figure 2
Protocol for the examination of damage to copper conductors from fire scenes.

In the laboratory, there are four techniques used to further study localized damage to conductors and other electronic devices and appliance subcomponents. These analytical techniques include: 1) cleaning by ultrasonic and/or plasma etching; 2) imaging by stereomicroscopy and/or radiography; 3) chemical analysis by Energy Dispersive X-ray Spectroscopy; and 4) examination of microstructure by metallography⁸. The various techniques and their ability to distinguish between the various causes of damage to conductors is illustrated in **Figure 2**.

Cleaning with an abrasive, such as glass fiber pens, can damage finer features on the surface. The best method for examining arc damage is an ultrasonic cleaner and mild detergent in hot water. For this, more time may be required to remove stubborn surface debris. Microscopy, using a stereomicroscope or equipped camera, preserves the arc site's appearance and should include the area of clear demarcation and the condition of the conductor away from the arc site. A second distinguishing feature of an arc site is internal porosity. High resolution, two-dimensional radiography is capable of distinguishing voids in the otherwise solid melt. X-ray is a non-destructive option to confirm the presence or absence of porosity compared to metallography.

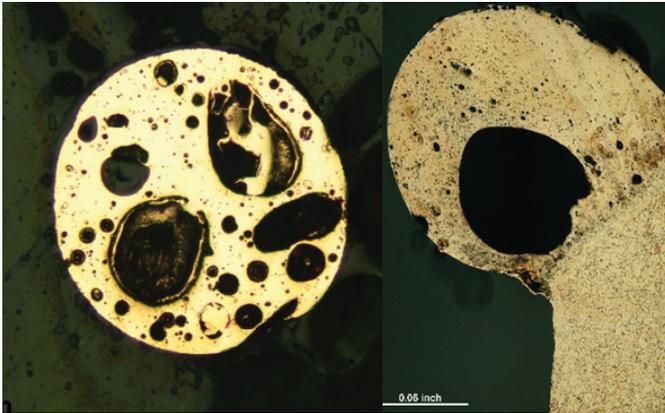
Figure 3
Arc sites to copper conductors.

A number of authors have investigated arc sites in detail using one or more of the above techniques. Laboratory-created arc sites are analyzed and compared with arc sites and fire melting from the field to establish the list of arc site characteristic attributes. Photographs of arc sites and fire melting are contained in NFPA 921 Chapter 9, Pt. 9.10, entitled *Interpreting Damage to Electrical Systems*¹. Additional examples of arc sites are shown in **Figure 3**.

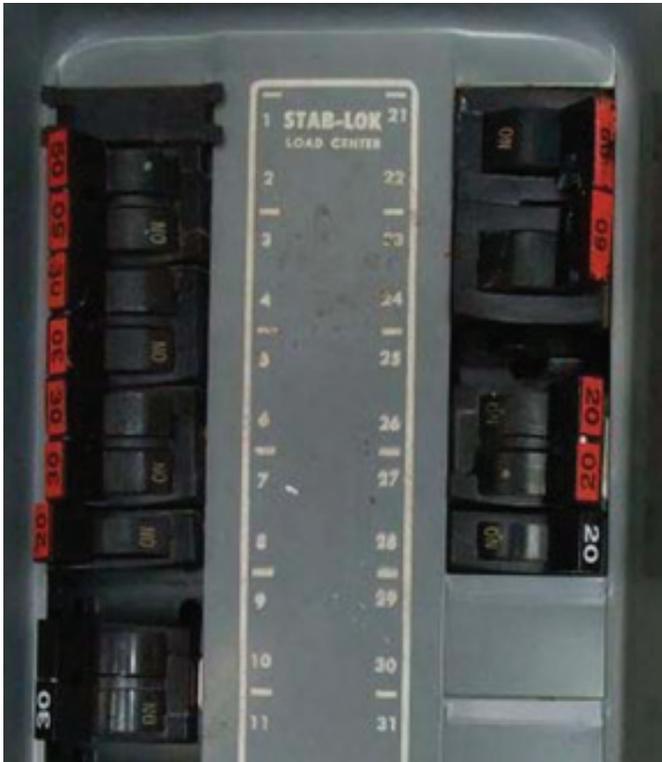
Figure 5
Federal Pacific Electric (FPE) panel.

transition in the copper from the melt to non-melt regions. When a breaker is slow to trip, this can result in multiple arc sites being present or in the wiring having the appearance of the melt. A typical FPE breaker panel is shown in **Figure 5**.
