EXAMINATION OF FIRE DAMAGED  
METAL OXIDE VARISTORS  
Mark Goodson, PE Lee Green, PE

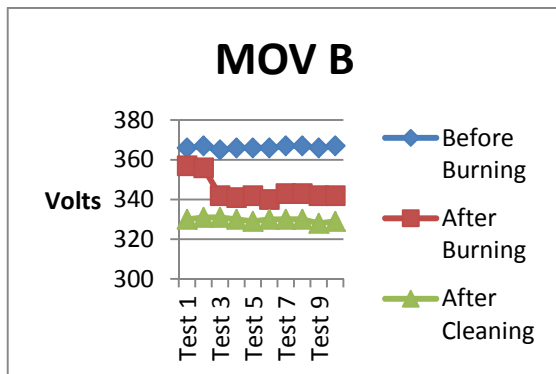
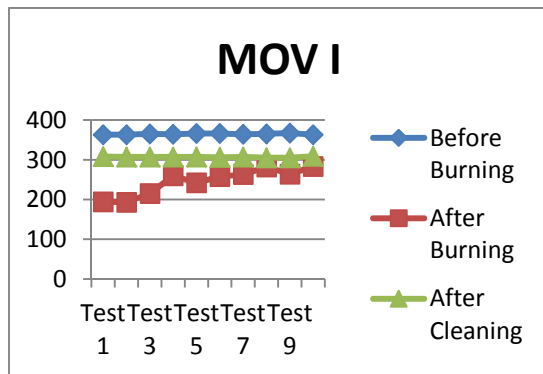
What can be stated is that for all 48 MOVs, there was a downward shift in the breakdown voltage. In no case did the voltage rise. This data alone is helpful, in that a post fire breakdown voltage on an MOV that is above the line voltage can immediately be dismissed in terms of having the MOV causing the fire.

The finding that was the most puzzling was the change in breakdown voltage between *pre* and *post* clean states. There was not a monotonic change. For some MOVs, cleaning caused the breakdown voltage to increase (as would be expected), and at times the breakdown voltage dropped after cleaning. The enclosed graphs show that MOVs V, F and M all had rises in breakdown voltages after cleaning, while MOVs U and O saw voltages drop after cleaning. The MOV G functioned almost the same before and after cleaning.
