USE OF BOND WIRES IN ICS IN FIRE INVESTIGATION

Mark Goodson PE
Lee Green PE
Michael Shuttlesworth PE
Goodson Engineering
Denton, Texas USA

ABSTRACT

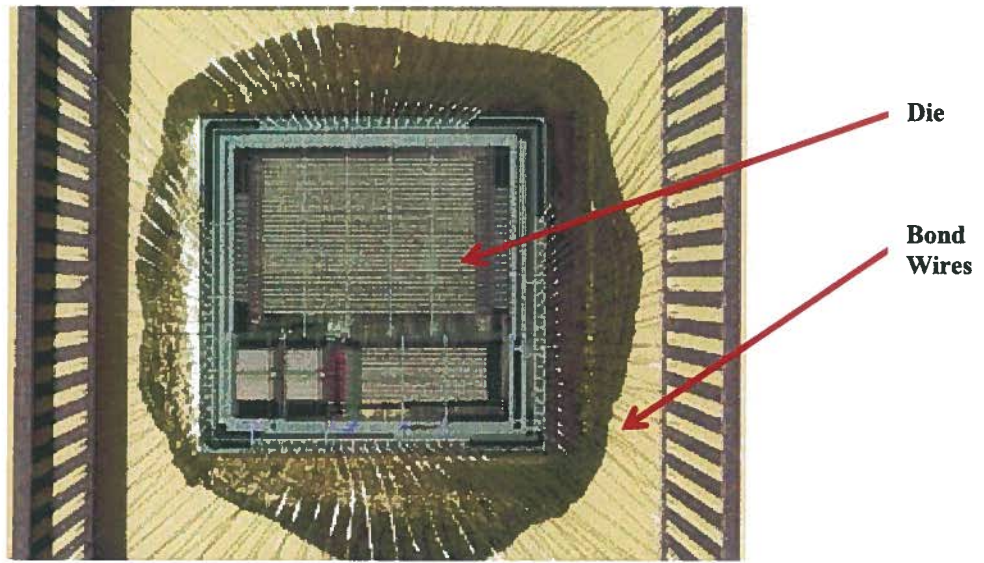
Photo 1 - Chip Within IC Showing Numerous Bond Wires

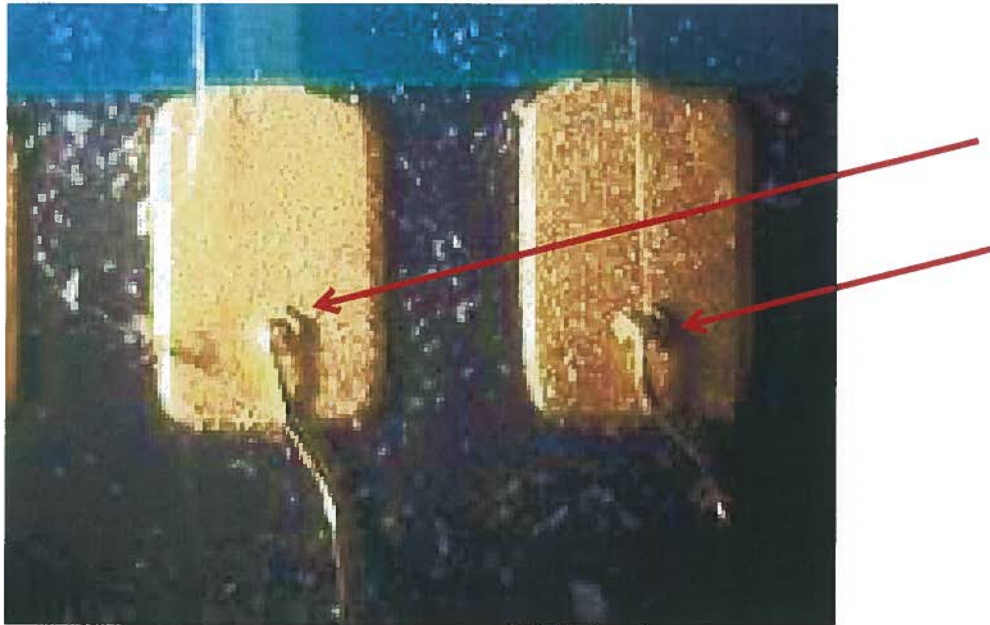
Photo 2 – Ball Bonds On Gold Pads, Indicated By Red Arrows

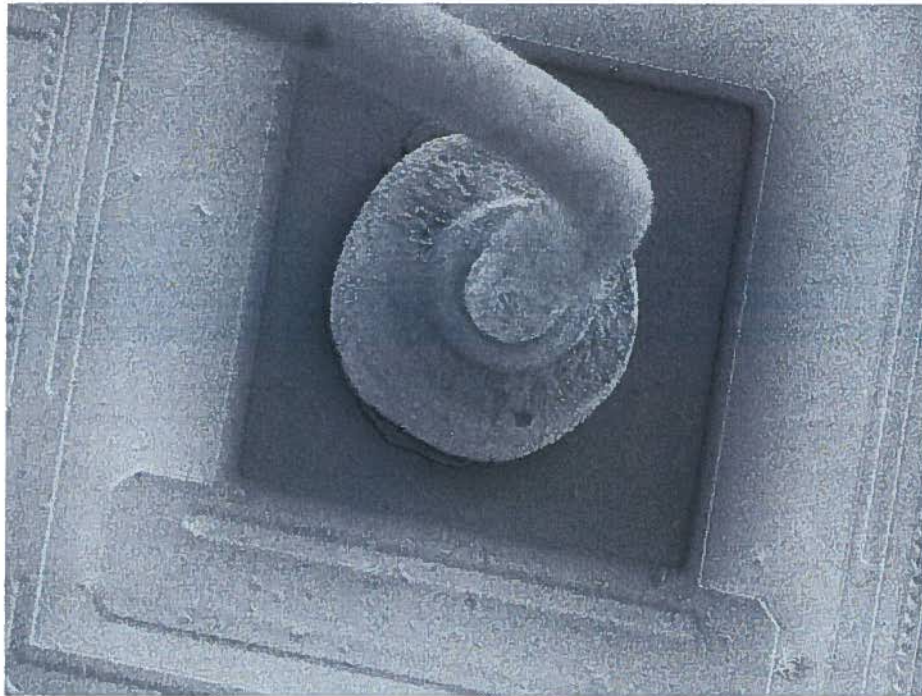
Photo 3 – SEM View Of Au Ball Bond And Bond Wire

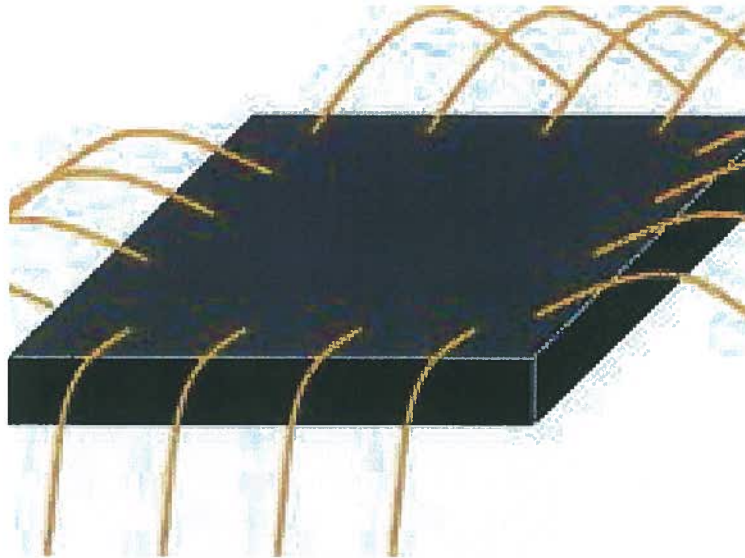
What is important to remember is that the IC has a number long, gold wires; Photo 4 depicts such wires. These gold wires have a high melting point, 1948 deg F. Moreover, the IC housing (typically a thermoset plastic or epoxy) will shield the Au wires from the heat of the fire. In essence, each IC has a number of internal fuses which can be analyzed after a fire, to see if any of the fuses have blown.

Photo 4 – Diagram Of Bond Wires On An IC

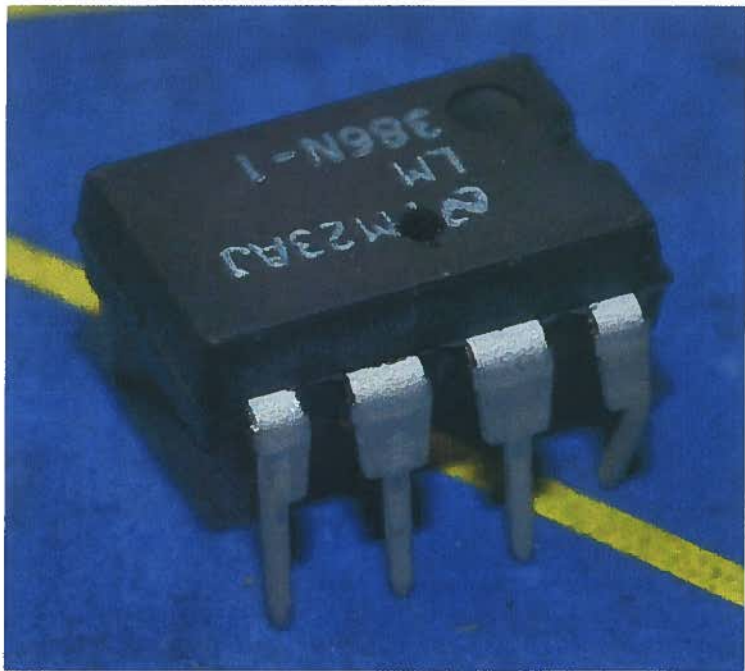
Photo 5 Depicts A 8 Pin DIP Package, With The Chip And Wires Encased In Epoxy

Photo 5 shows an 8 pin IC, known as a DIP (Dual In-line Package). The chip, wires, and part of the leads are encased in the thermoset (epoxy) plastic housing. This IC is a LM 386, which is an audio amplifier. An x-ray view of the LM 386 is shown in photo 6.

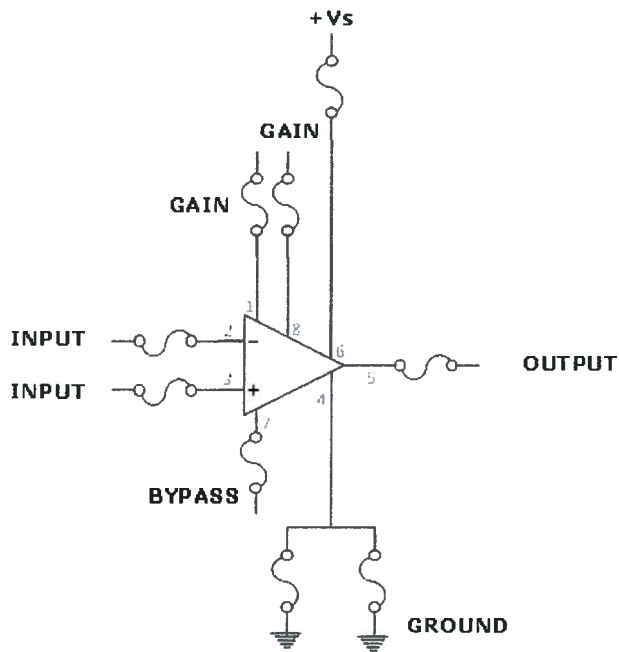
Photo 7 – Schematic Of LM 386 With Fusing, As Well As Double Fuse On Ground

We took an LM 386 amplifier, and applied 36 volts to it, across the Vcc and ground terminals. Testing of the IC thereafter showed that it had failed. MF RT x-ray showed that a wire was missing, corresponding to pin 4. Photo 8 shows the location of the missing wire. After noting the missing wire, the IC was subjected to CT (Computed Tomography) and then reconstruction. For software, we used a program called *Volume Graphics (VG)*, published in Germany. Using VG, the reconstructed image was analyzed, and is shown in Photo 9. The VG reconstruction shows that the bond wire serving pin 6 has evaporated. A review of the schematic shown in Photo 7 indicates that pin 7 is Vcc, the supply pin.
