INVESTIGATING THE CAUSAL LINK BETWEEN LIGHTNING STRIKES, CSST AND FIRE

Mark Goodson, PE and Mark Hergenrether, MSME

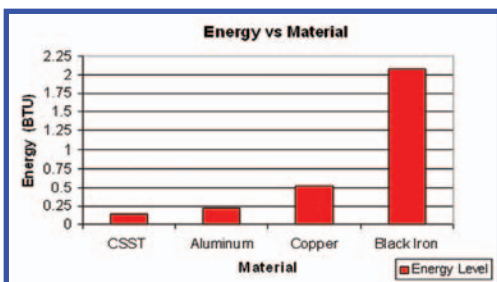
For an equivalent 100-mil diameter hole, we can calculate the values for heat capacity based on the aforementioned equation. Figure 2 is a plot of the respective values for each material. The amount of energy to create a 100-mil diameter hole is much greater for black iron pipe than for any of the

Figure 2: Comparison of heat capacity for 100 mil diameter hole in CSST, Aluminum, Copper & Black Iron.
