# **PLASMA ETCHING TO HELP IDENTIFY ACOUSTIC AGGLOMERATION SOOT PATTERNS ON SMOKE DETECTOR PIEZO DISKS**

William A. Steward  
Goodson Engineering, USA  
and  
Mark E. Goodson, PE  
Goodson Engineering, USA

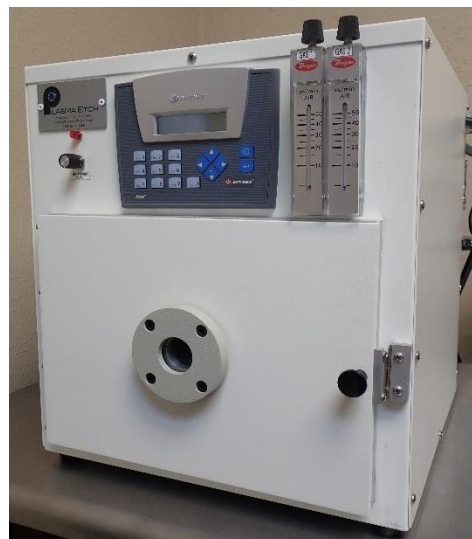
Figure 1 – PE-50 Plasma Etch

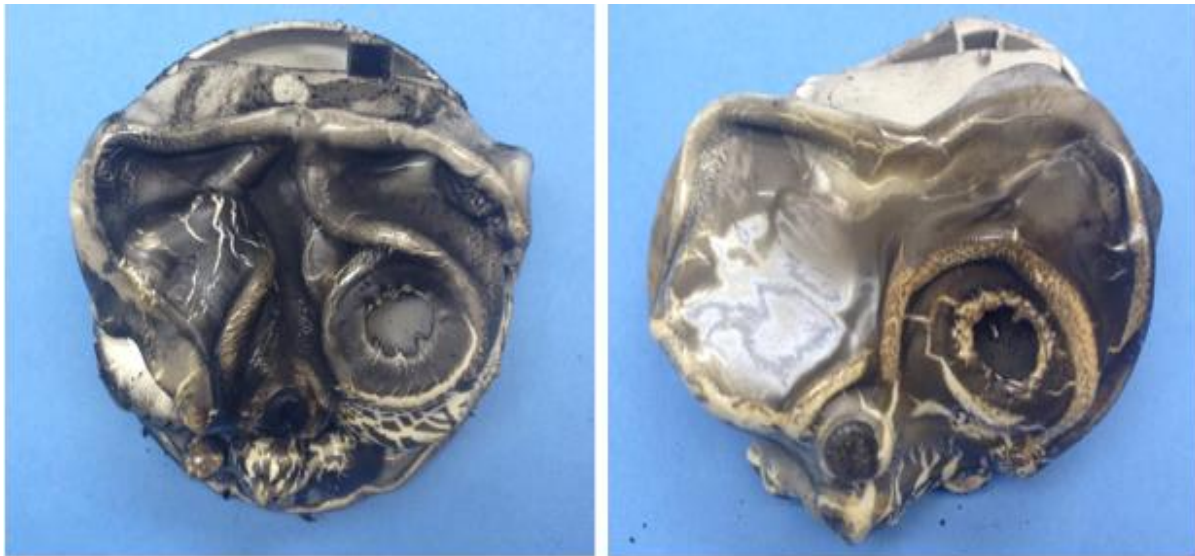
**Figure 6 – Smoke detectors that were damaged during the fire.**

In the previous section, the smoke detectors were not damaged by fire. This made it possible to view the soot deposits on the outside of the detectors to look for acoustic agglomeration patterns. When the outer polymer case is damaged, it is extremely difficult and sometimes impossible to determine if the alarm was sounding at the time of the fire.
